2021 South Amelia Island, FL Beach Nourishment Project

FDEP Permit No. 0187721-013-JC
USACE Permit No. SAJ-2001-03870 (SP-PRJ)

Year 2 Post-Construction Monitoring Report

YEAR TWO POST-CONSTRUCTION MONITORING REPORT

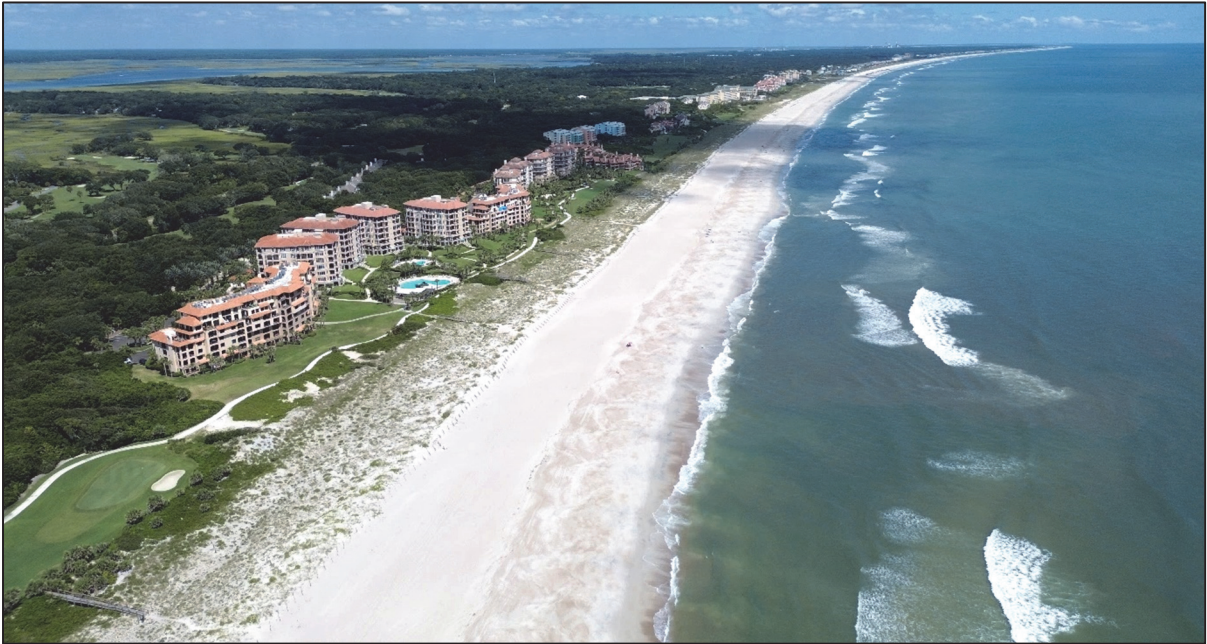
Photograph EX.1: Northward looking view at R-69 (Sea Dunes) on 27-August-2023.

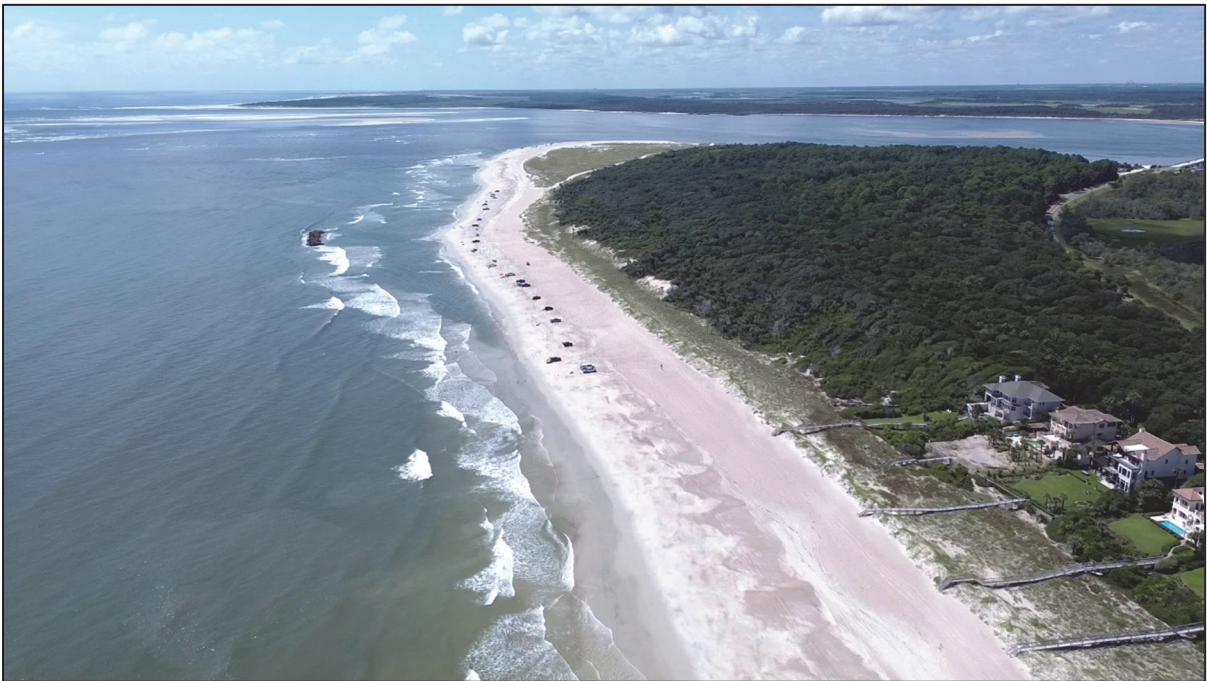
Photograph EX.2: Southward looking view toward the detached breakwater from The Sanctuary (AP-20) on 27-August-2023.

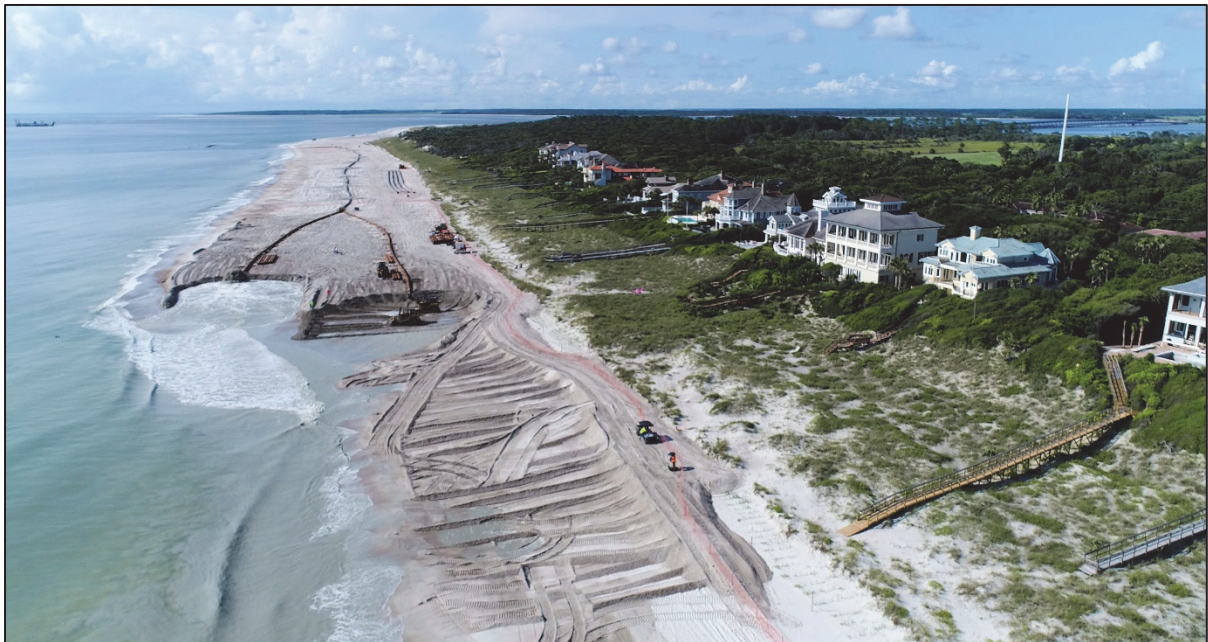
Photograph 1.1: Southward view of the beach fill construction progress at The Residence on 11 Aug, 2021 near Station 65+00 (R-72).

The project was constructed between July 27, 2021 and January 16, 2022 by S.J. Hamill / Marinex Construction, Inc. The Contractor employed the 24-inch cutterhead-suction pipeline dredge *Savannah*. The *Savannah* was also used for the 2011 nourishment. The fill limits of the 2021 renourishment of the South Amelia Island Beach Nourishment Project covered approximately 17,100 feet (3.2 miles) of the Atlantic Ocean shoreline (**Figure 1.1**). The project placed 1,858,000 cubic yards of beach quality sand (approximate total volume) from roughly R-59.5 southward to AP-25 (~R-76.5), approximately 2,300 feet north of the existing rock terminal groin. Fill tapers were constructed at both ends of the project to transition the fill to the existing shoreline. **Photograph 1.1** shows construction activities in the vicinity of The Residence (~R-72) on August 11, 2021.

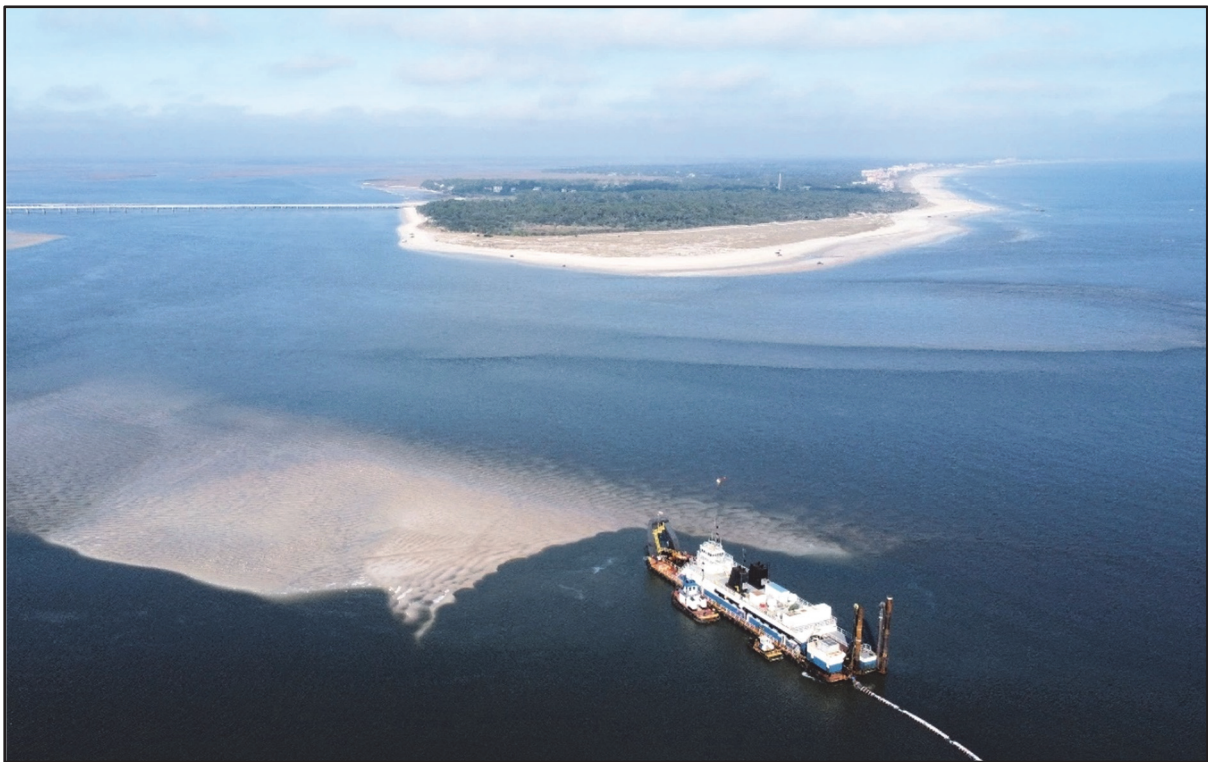
Photograph 1.2: View northward toward South Amelia Island of the Dredge Savannah excavating the shoal borrow area in Nassau Sound. (30 Dec. 2021)

Sand for the project was excavated from a 140-acre (56.6 hectare) borrow area located south-southeast of the southern tip of Amelia Island on the Nassau Sound ebb shoal. The borrow area connects one of the main tidal channels through Nassau Sound to the Atlantic Ocean in a fashion that mimics historic marginal tidal channels through the ebb shoal. A supplementary borrow area located on the outer contours of the ebb shoal was designed to be utilized in the event of a volume shortfall during a future project or for use immediately following a severe storm event. The supplemental borrow area was not utilized during the 2021 project. The permitted design depth of the borrow area varied between -17.0 and -18.0 ft-NAVD. **Photograph 1.2** shows dredging activities at the borrow area on December 30, 2021.

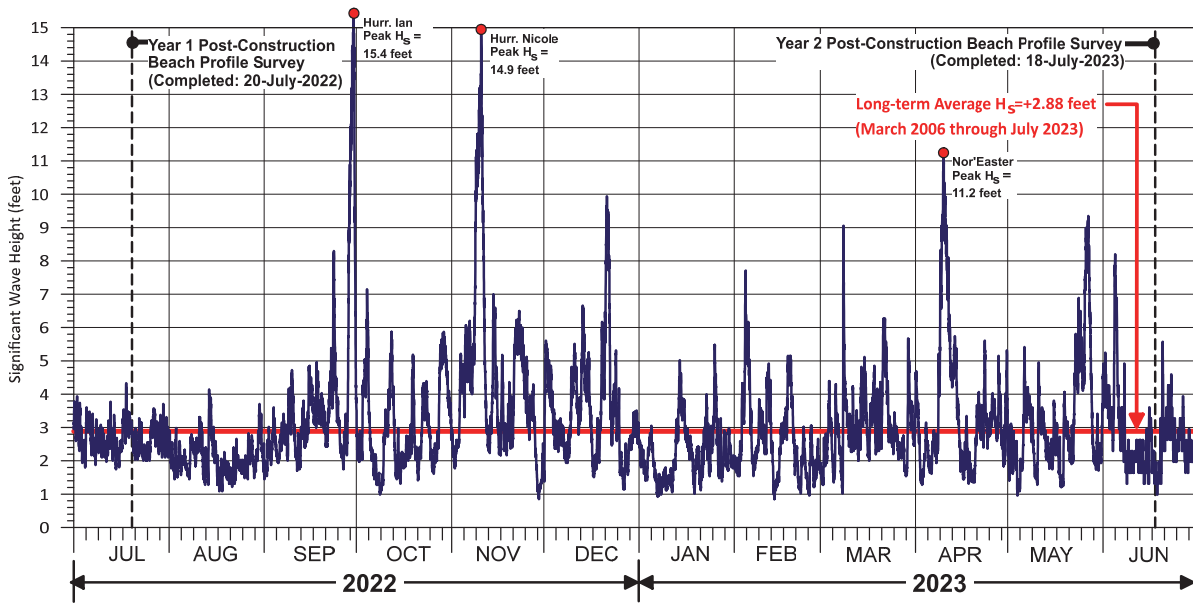
Figure 1.4: Offshore wave conditions measured during Year Two post-construction of the 2021 South Amelia Island Beach Nourishment Project. Wave data were obtained from NOAA at offshore data buoy 41112 (Fernandina).

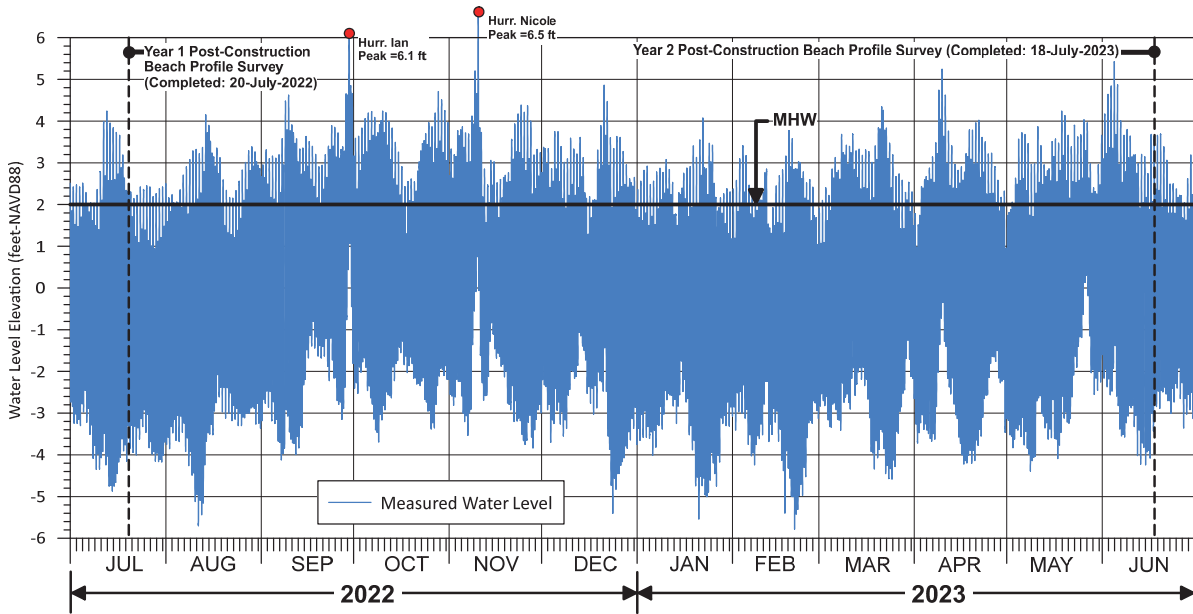
Figure 1.5: Water levels measured during Year Two post-construction of the 2021 South Amelia Island Beach Nourishment Project. Water level data were obtained from the Fernandina Beach tide station (8729840). Note that this tide station does not directly indicate the water levels along the open coast of south Amelia Island during the height of the storm.

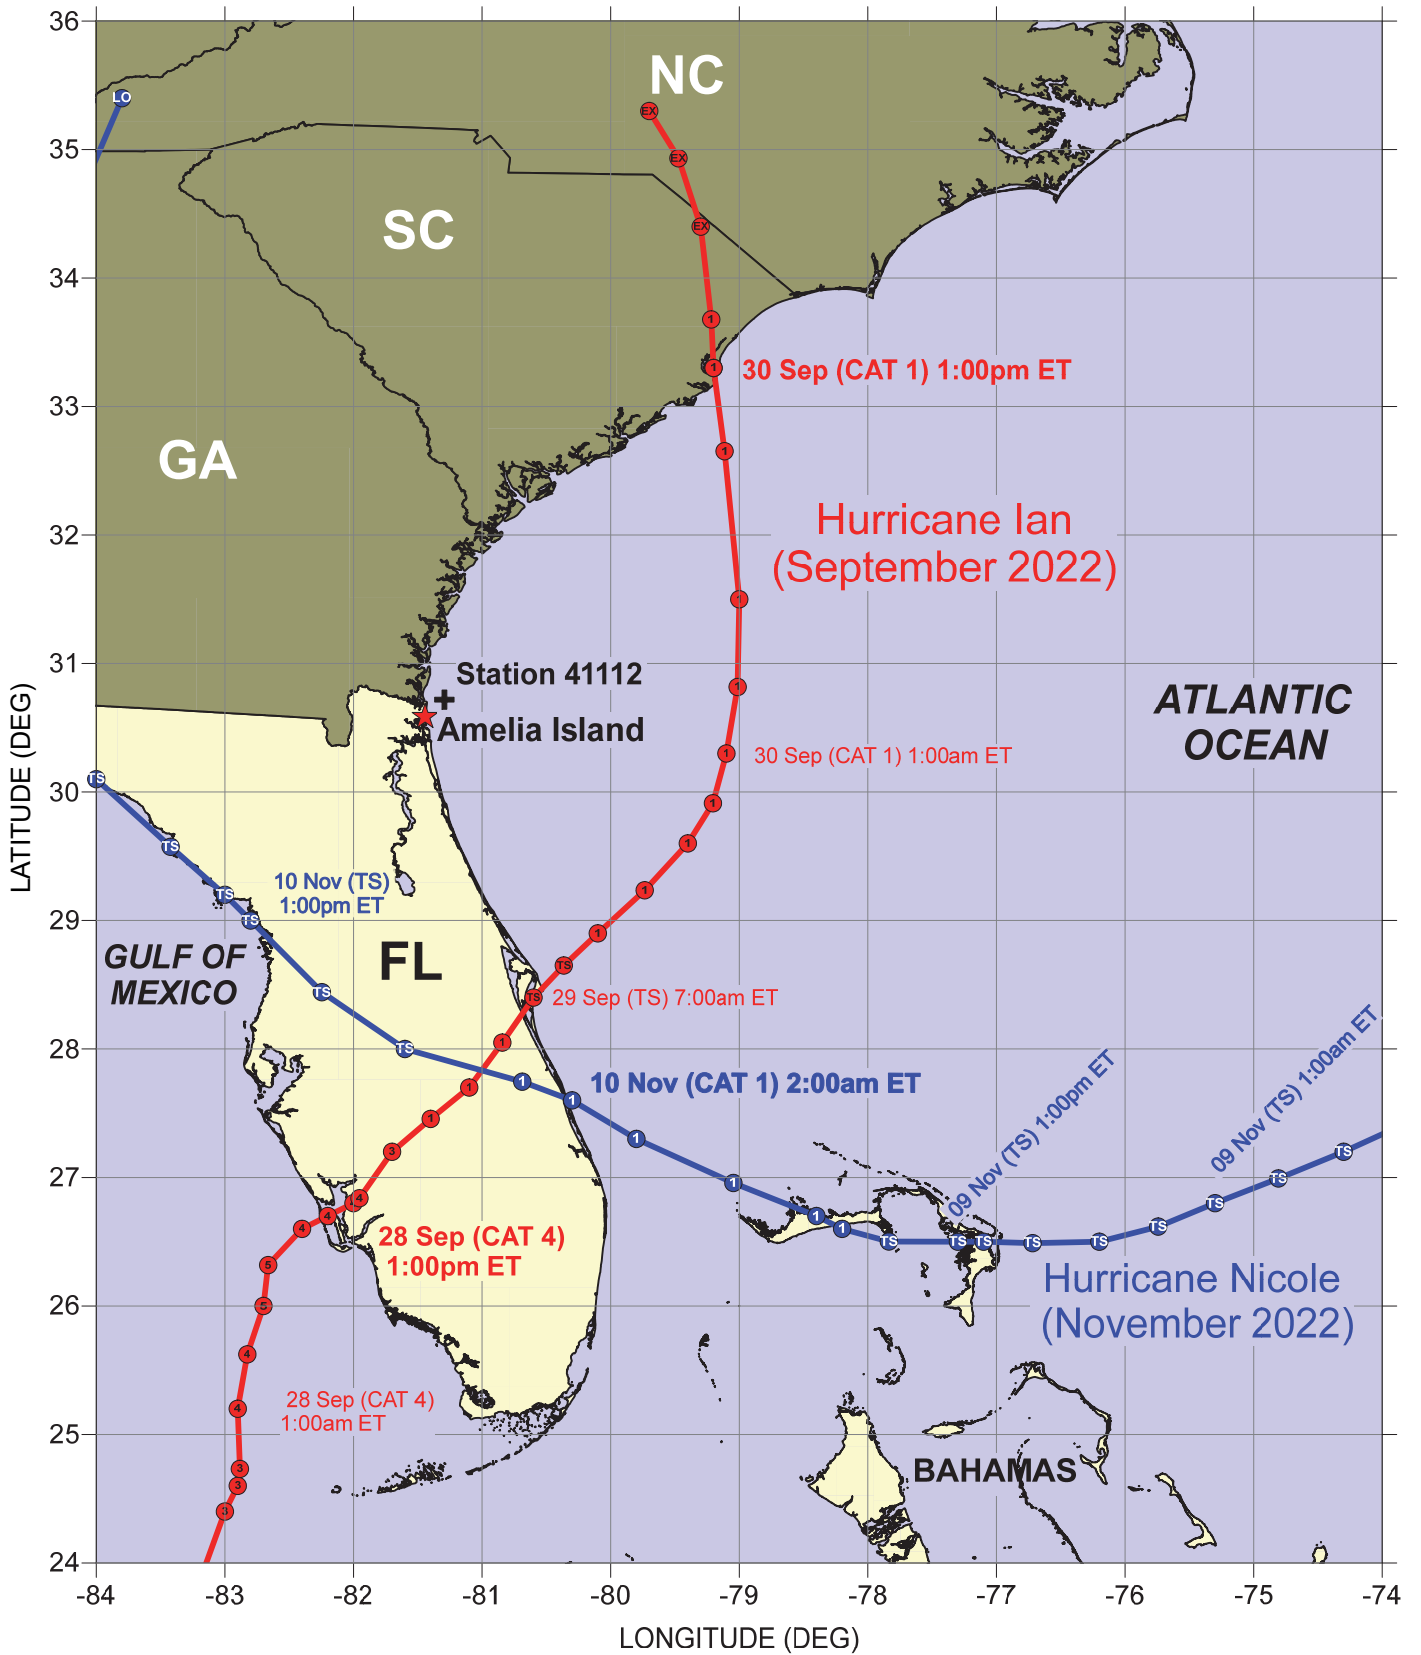
Figure 1.6: Storm Tracks of Hurricane Ian (Sept. 2022) and Hurricane Nicole (Nov. 2022).

As mentioned, Hurricanes Ian and Nicole impacted the project area in 2022. A post-Nicole survey of the SAISSA project limits in January 2023 revealed a storm-related loss of 301,850 cy above -20 ft NAVD. The June 2023 surveys suggest that some level of recovery may have occurred since that time, although the recovery appears to be concentrated in the offshore portions of the profile. It is recognized that a) storm erosion affected the entire Amelia Island shoreline, hence some of the measured accretion may be the result of sand migrating into the project limits from the north, and b) the offshore areas of the survey carry the most uncertainty in calculation, due to the limited transect data used to characterize the broad offshore areas of the beach profiles. Future surveys will assist in further refining the offshore volume changes.

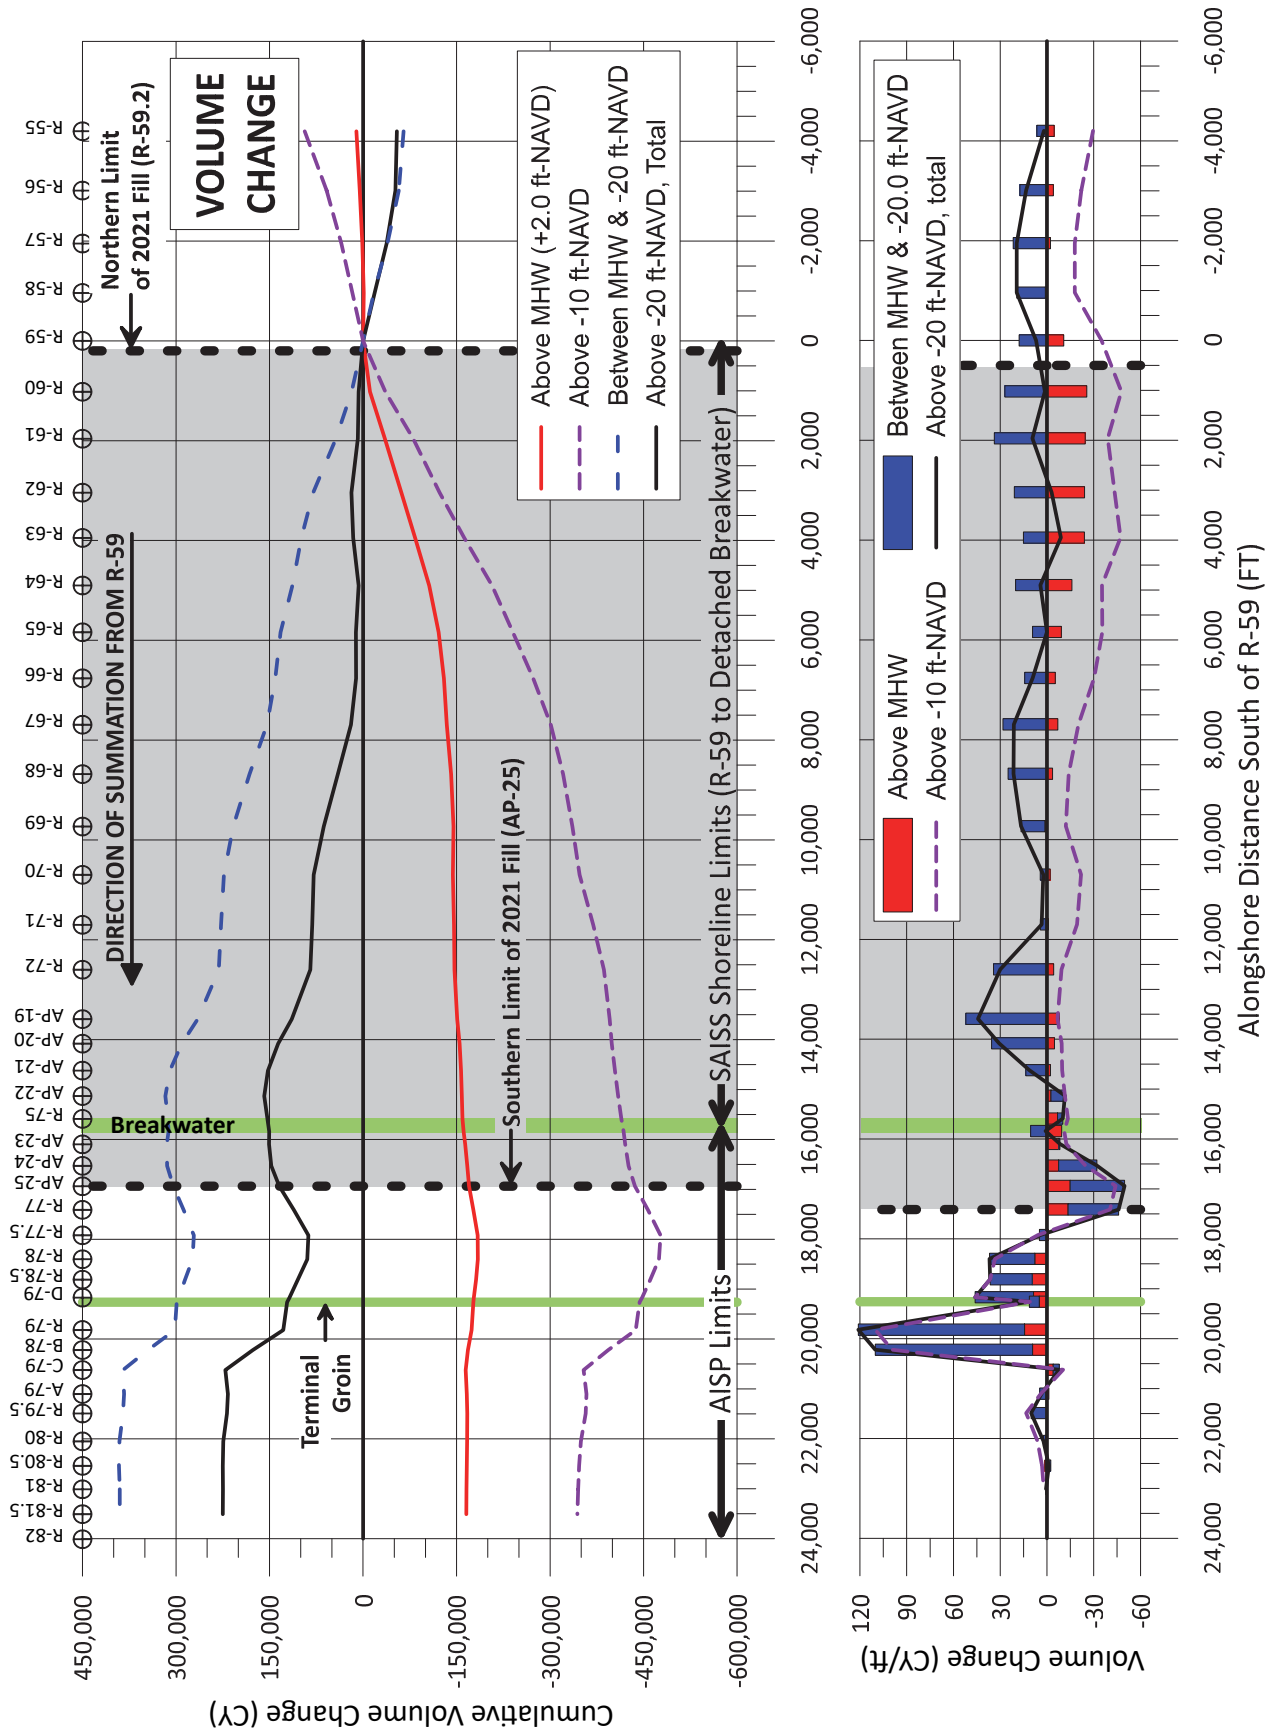
On weighted average, the berm and MHWL receded by about -84.4 ft and -35.3 ft, respectively. The largest overall shoreline recession was observed near the northern end of the fill (**Figures 2.4 and 2.5**). The largest berm recession occurred at R-60 (-160.4 ft), located at the old 16th fairway and the largest MHWL recession occurred at R-63 (-86.2 ft), located at Sand Castles.

Figure 2.3: Recent intersurvey beach volume changes (July 2022 to June 2023), South Amelia Island, FL.

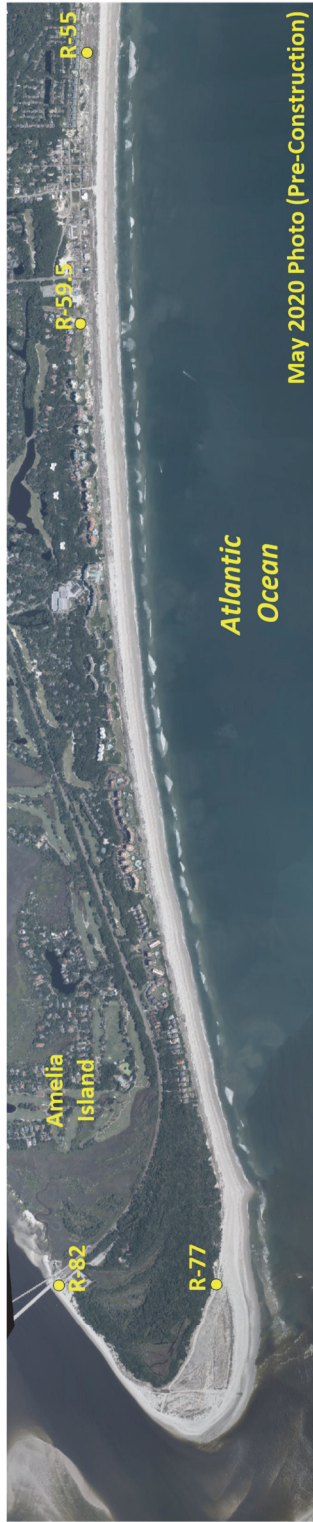
Figure 2.4: Post-, Year-1 and Year-2 post-construction BERM locations changes relative to June 2021 pre-construction location.
Note: Upland beach access is limited by the park due to concerns regarding potential impacts to nesting shorebirds resulting in some profile surveys not extending up to the berm elevation.

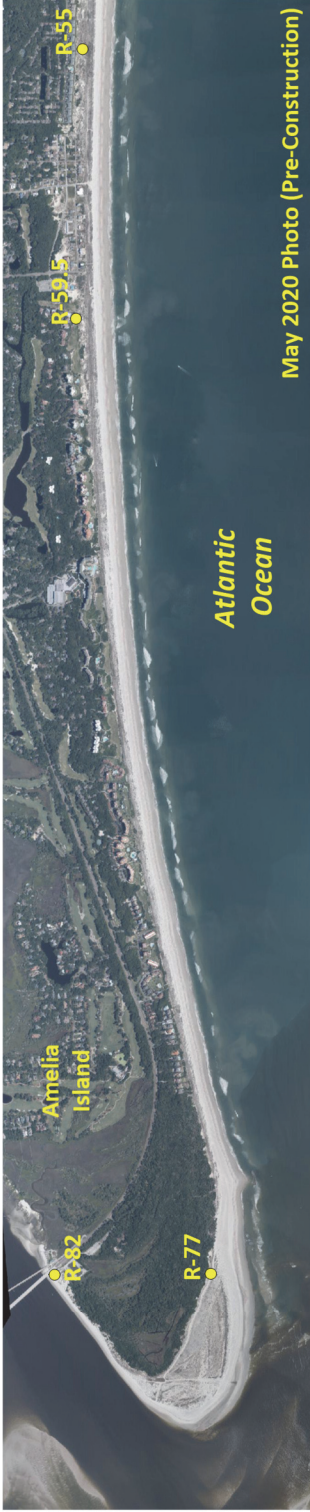
Figure 2.5: Post-, Year-1 and Year-2 post-construction MHWL locations changes relative to June 2021 pre-construction location.

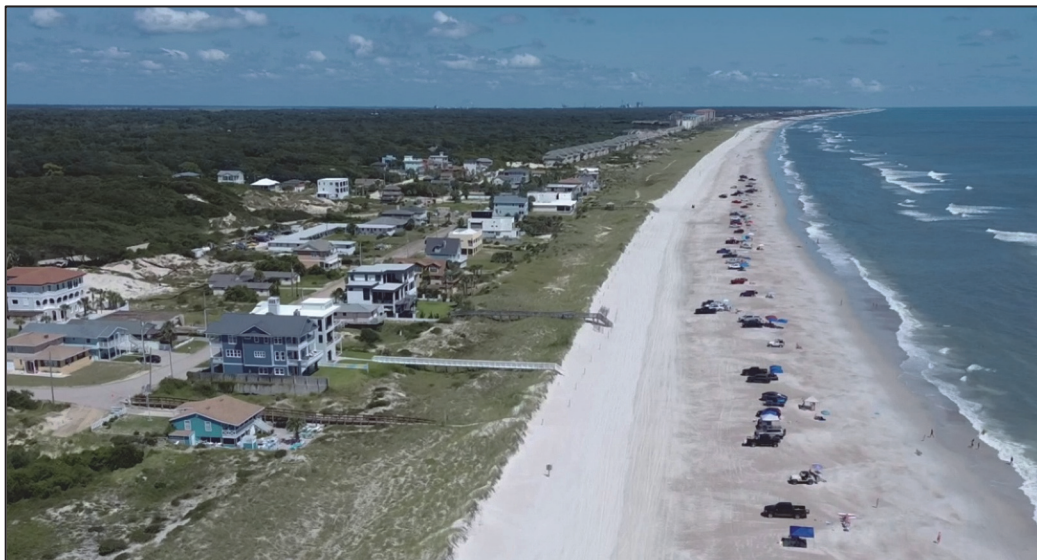
North of the project area (R-55 to R-59), the 4,200 ft of shoreline experienced a loss of -10,900 cy (-2.6 cy/ft) above the MHWL and a gain of +65,100 cy (+15.5 cy/ft) below the MHWL for a net gain of +54,200 cy (+12.9 cy/ft) above -20 ft-NAVD. During this period the berm receded by a weighted average of -4.5 ft while the MHWL advanced by +13.9 ft. The volume gains and advance of the MHWL observed here may be attributed to the spreading of beach fill northward toward the adjacent shoreline. The retreat of the berm and erosion above the MHWL in this segment are the result of storm waves which eroded some of the dune during this period. **Photograph 2.1** shows the shoreline conditions looking north at R-59 (Burney Park) on August 27, 2023.

Photograph 2.1: Northward looking view at R-59 (Burney Park) on 27-August-2023.

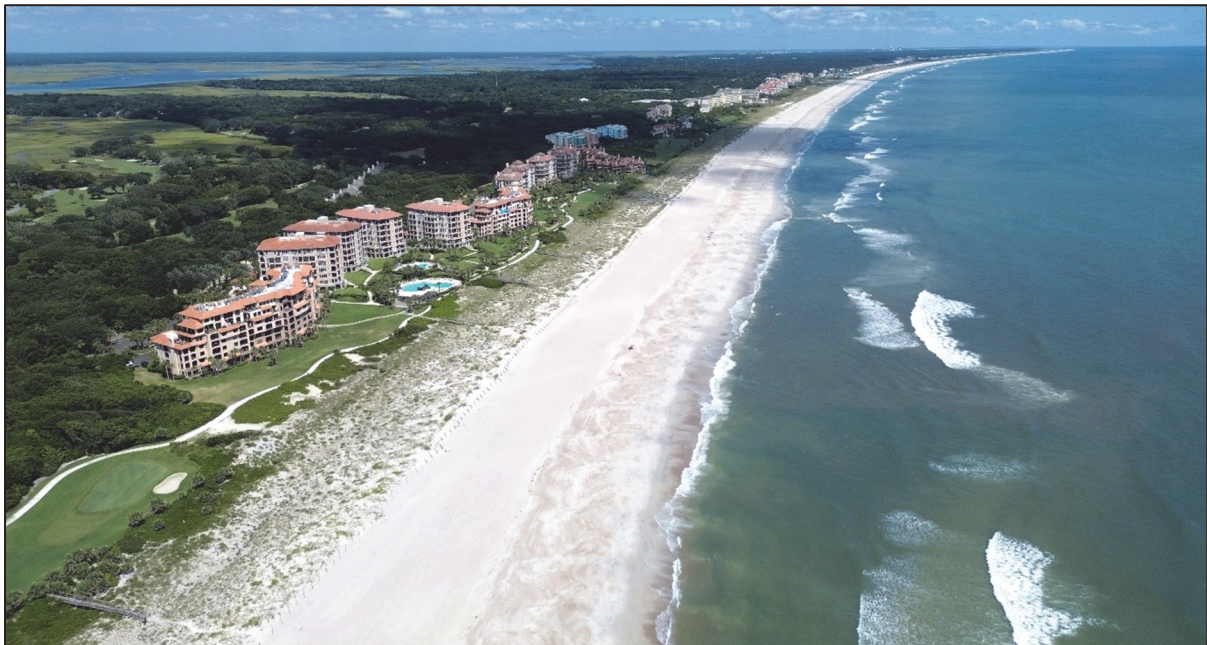
Photograph 2.2: Northward looking view at R-69 (Sea Dunes) on 27-August-2023.

Along the SAISS project area (R-59 to the detached breakwater), the 15,840 ft of shoreline lost roughly -161,300 cy (-10.2 cy/ft) above the MHWL and gained +312,000 cy (+19.7 cy/ft) below the MHWL for a net gain of +150,700 cy (+9.5 cy/ft) above -20 ft-NAVD. Above the approximate toe of fill (-10 ft-NAVD), the shoreline lost -417,800 cy during Year-2 or approximately -23.4 percent of the estimated +1,786,431 cy placed along this project reach (BD/AD total placed estimate). The overall net volume gain suggests the lost volume remains on the project shoreline in the submerged nearshore, principally between depths of 10 to 20 ft, offshore of the primary bar in the profile. During this period, the berm and MHWL receded by weighted averages of -82.0 ft and -33.1 ft, respectively. **Photograph 2.2** shows the shoreline conditions looking southward looking view at R-69 (Sea Dunes) on 27-August-2023

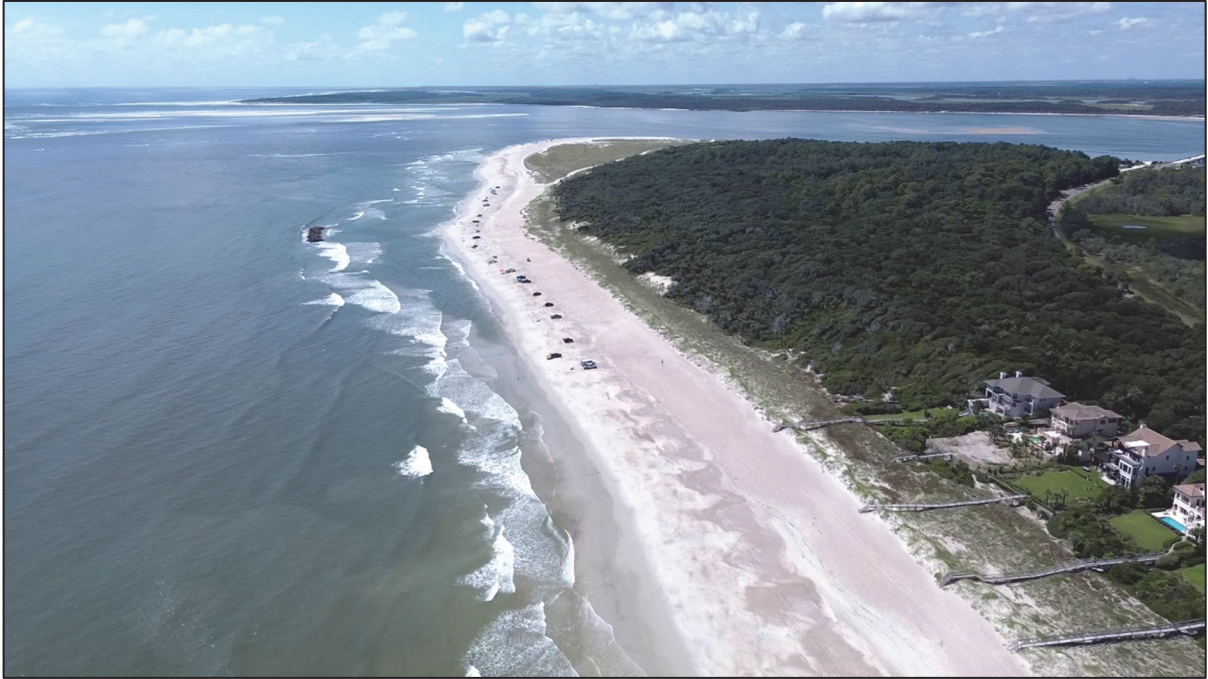
Photograph 2.3: Southward looking view toward the detached breakwater from The Sanctuary (AP-20) on 27-August-2023.

Along the AISP Atlantic shoreline (detached breakwater to terminal groin), the 3,420 ft of shoreline experienced a loss of roughly -15,600 cy (-4.6 cy/ft) above the MHWL and -13,200 cy (-3.8 cy/ft) below the MHWL for a net loss of -28,800 cy (-8.4 cy/ft) above -20 ft-NAVD. During project construction, approximately 71,645 cy (BD/AD total placement estimate) was placed between the detached breakwater (R-75+250 ft) to AP-25. Along this reach, the shoreline lost -18,300 cy during Year-2 above the approximate toe of fill (-10 ft-NAVD), or approximately 25.6 percent of the placed volume. During this period, the MHWL receded by a weighted average -43.4 ft. The weighted berm change was unable to be calculated along this reach as upland survey beach access was limited by the Park at one of the monuments for the post-construction survey due to concerns regarding impacts to nearby nesting shorebirds. **Photograph 2.3** shows the shoreline conditions looking southward from The Sanctuary (AP-20) and **Photograph 2.4** looking northward from the south end of Amelia Island on August 27, 2023.

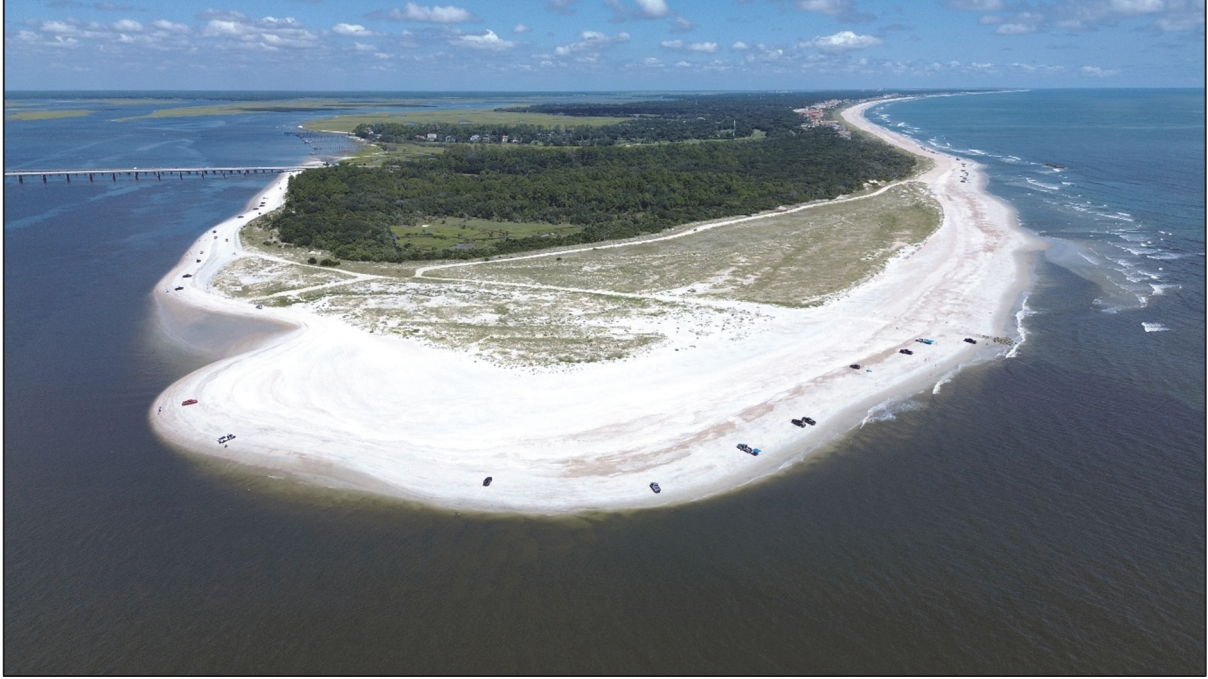
Photograph 2.4: Northward looking view from the south end of Amelia Island on 27-August-2023.

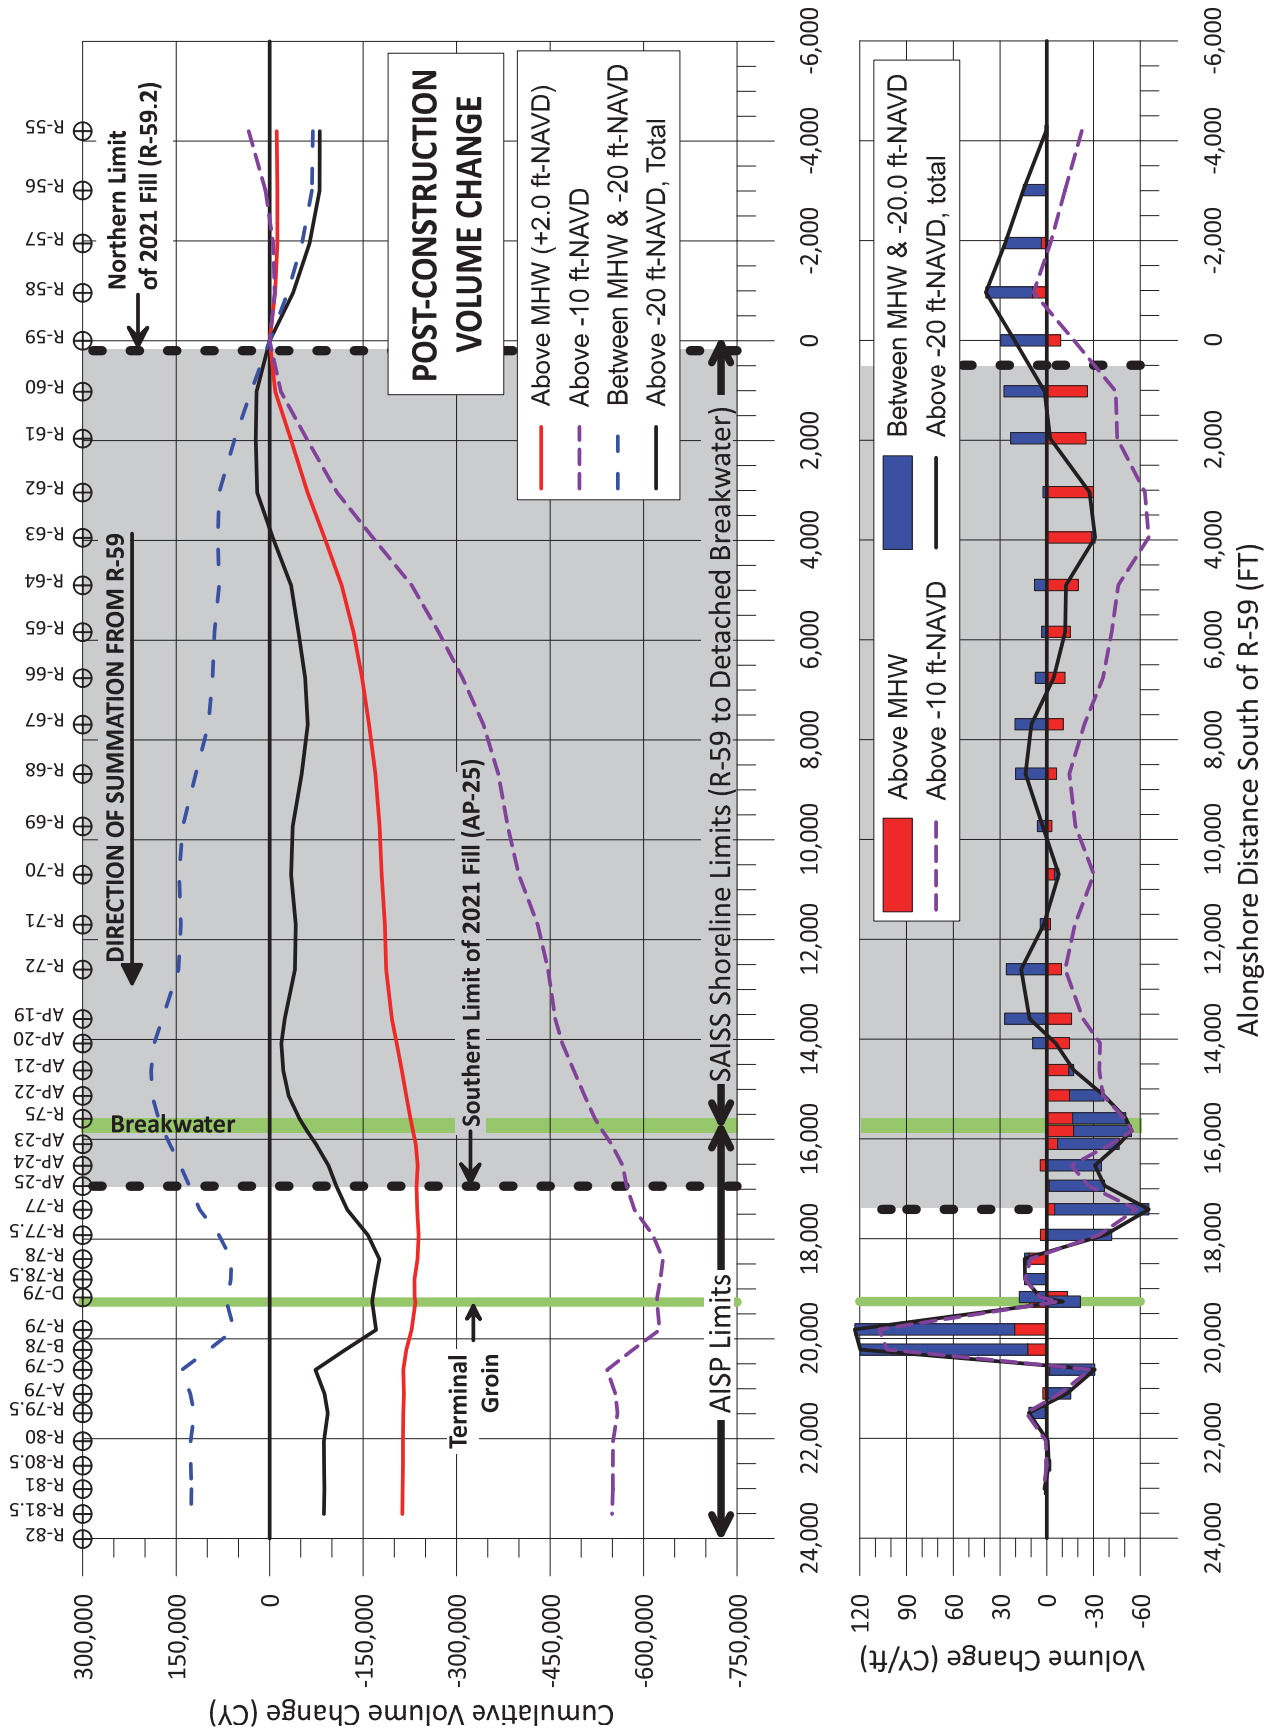
On weighted average, the berm and MHWL receded by about -92.0 ft and -54.9 ft, respectively. The largest shoreline recession was observed toward the north end of the fill (**Figures 2.4** and **2.5**). During this period, the largest berm recession occurred at R-60 (-152.2 ft), located at the 16th fairway and the largest MHWL recession occurred at R-63 (-123.9 ft), located at Sand Castles. Only three profiles (AP-23 through AP-25, around the breakwater and into the AISP property) exhibited a MHW position landward of the pre-construction MHWL. Overall, the beach remains roughly 106 ft (berm) and 89 ft (MHWL) seaward of the June 2021 pre-construction location.

Figure 2.7: Post-construction beach volume changes (January 2022 to June 2023), South Amelia Island, FL.

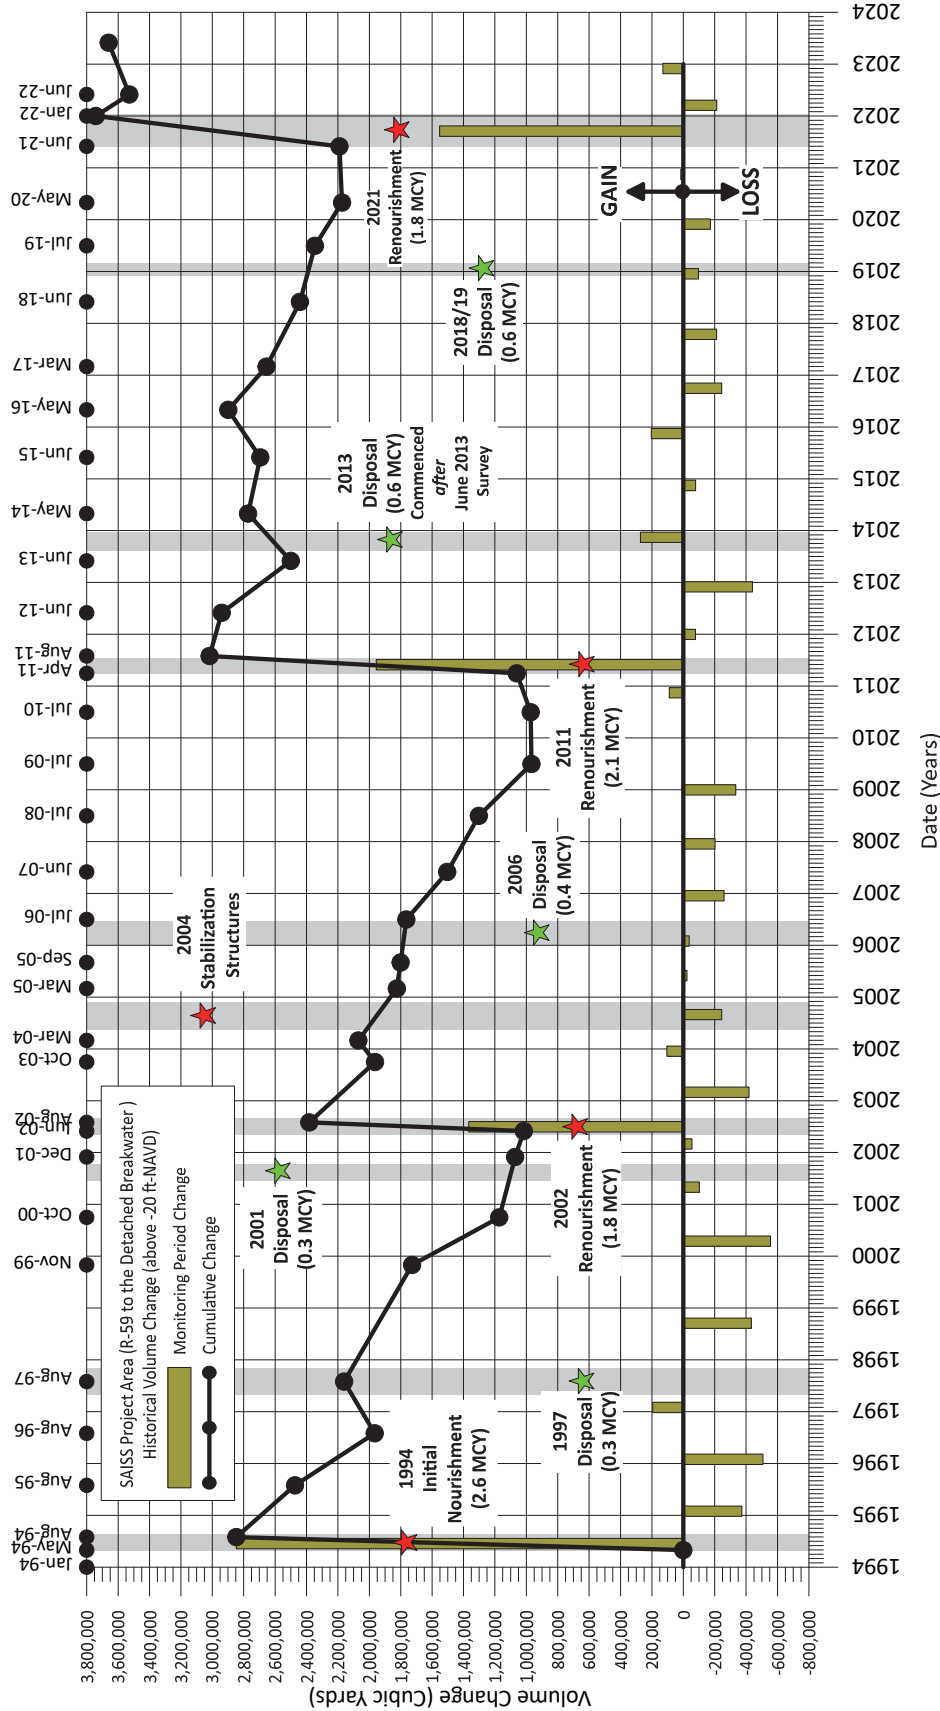
As of June 2023, the SAISS project shoreline has approximately +3,659,700 cy more sand relative to the pre-1994 project condition. Additionally, based upon an analysis of available survey data and aerial photography, the area immediately south of the fill area between the detached breakwater to R-82 is estimated to currently contain between 700,000 to 1,200,000 cy more sand than in May 1994. Similarly, the area immediately north of the project area between R-55 and the R-59, including American Beach and into Summer Beach, gained roughly +347,600 cy between May 1994 and June 2023.

In total, within the entire monitored area (R-55 to R-82), the shoreline has between 4.7 Mcy and 5.2 Mcy more sand as of June 2023 than in the May 1994 condition. During this same period, approximately 10.45 Mcy of sand was placed along this shoreline as part of the SAISS project or USACE beach disposal projects. Therefore between 45 to 50 percent of the sand placed since 1994 along the Amelia Island shoreline south of R-55 remains on the beach within the monitored area.

Figure 2.9: Historical volume change within the SAISS project area (R-59 to the detached breakwater), South Amelia Island, FL. Volume changes measured above -20 ft-NAVD

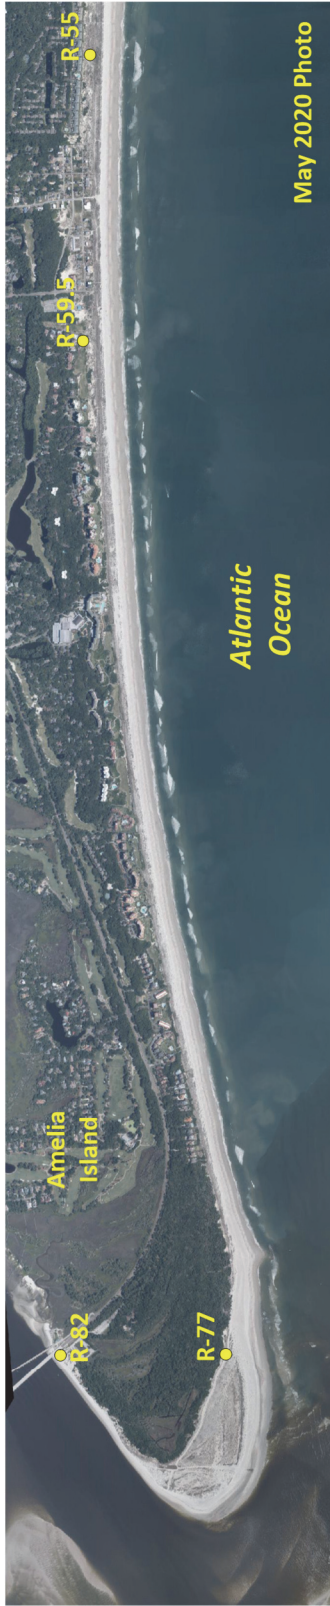
Figure 2.10: Long-term post-project MHWL positions relative to pre-1994 project location (May 1994), South Amelia Island, FL.
