2021 South Amelia Island, FL Beach Nourishment Project

FDEP Permit No. 0187721-013-JC
USACE Permit No. SAJ-2001-03870 (SP-PRJ)

Year 2 Post-Construction Monitoring Report

YEAR TWO POST-CONSTRUCTION MONITORING REPORT

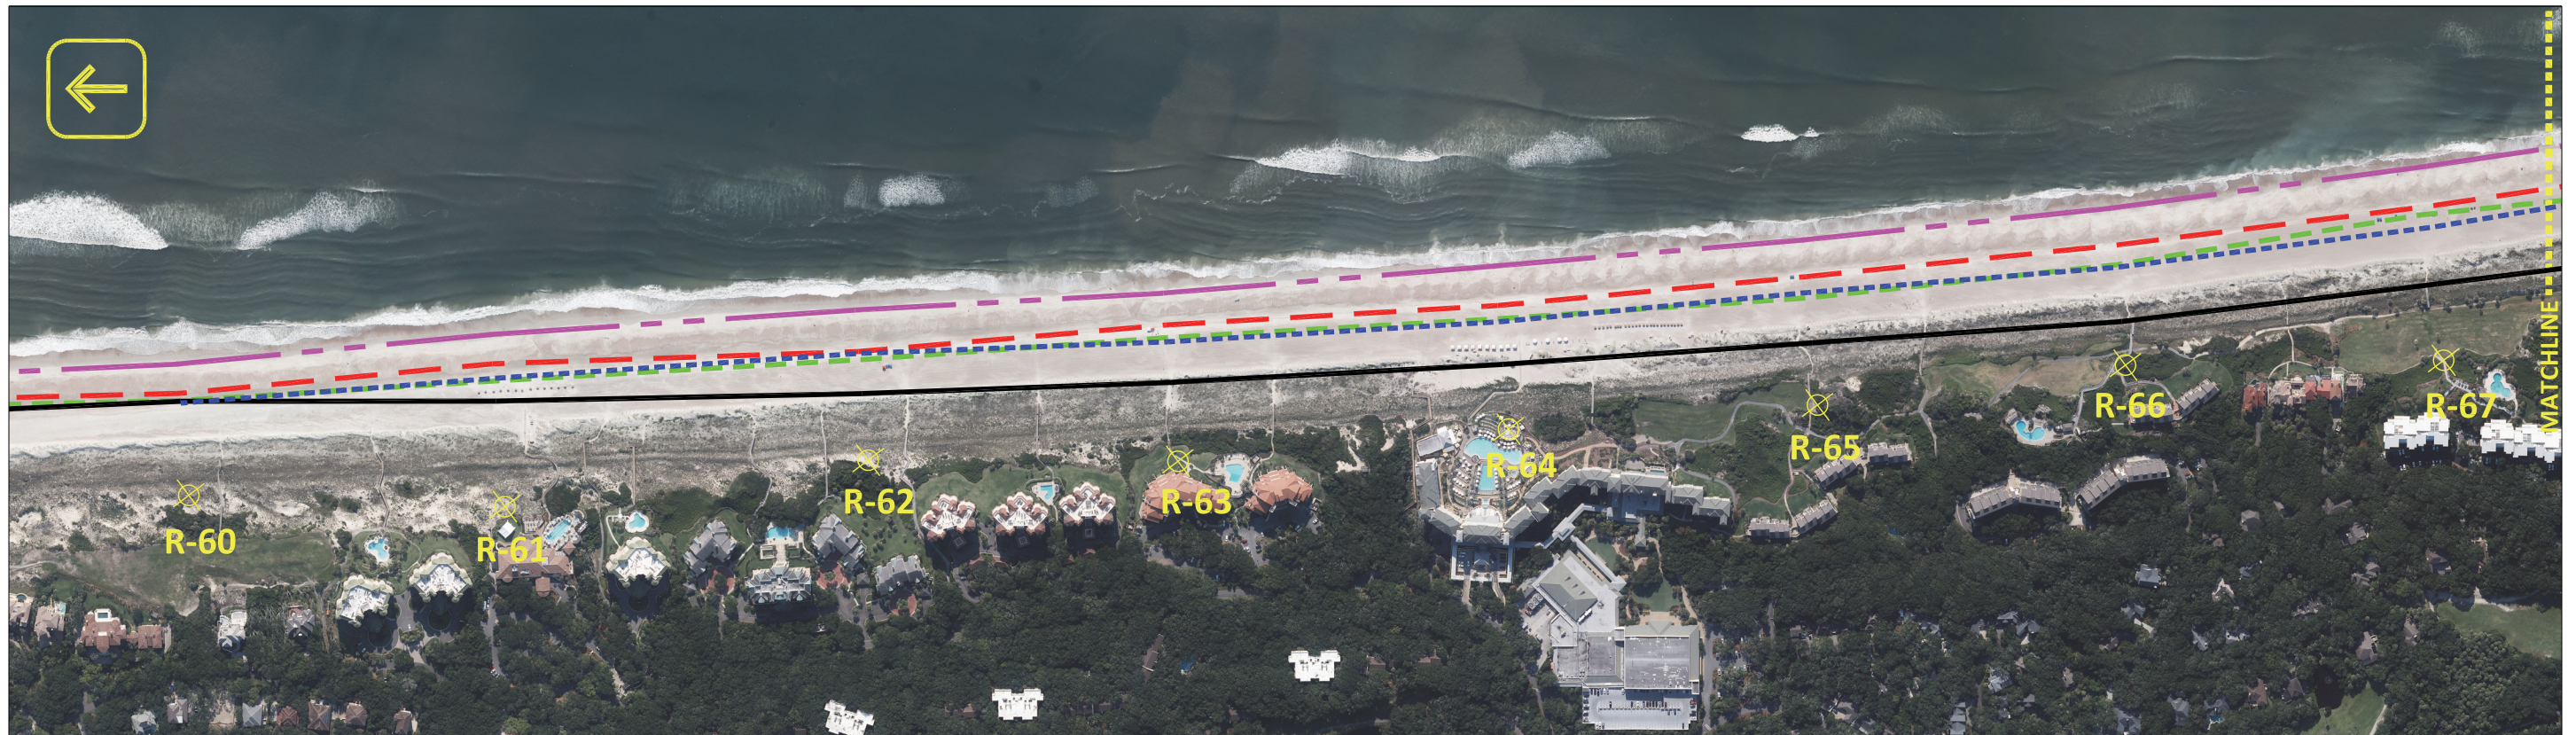
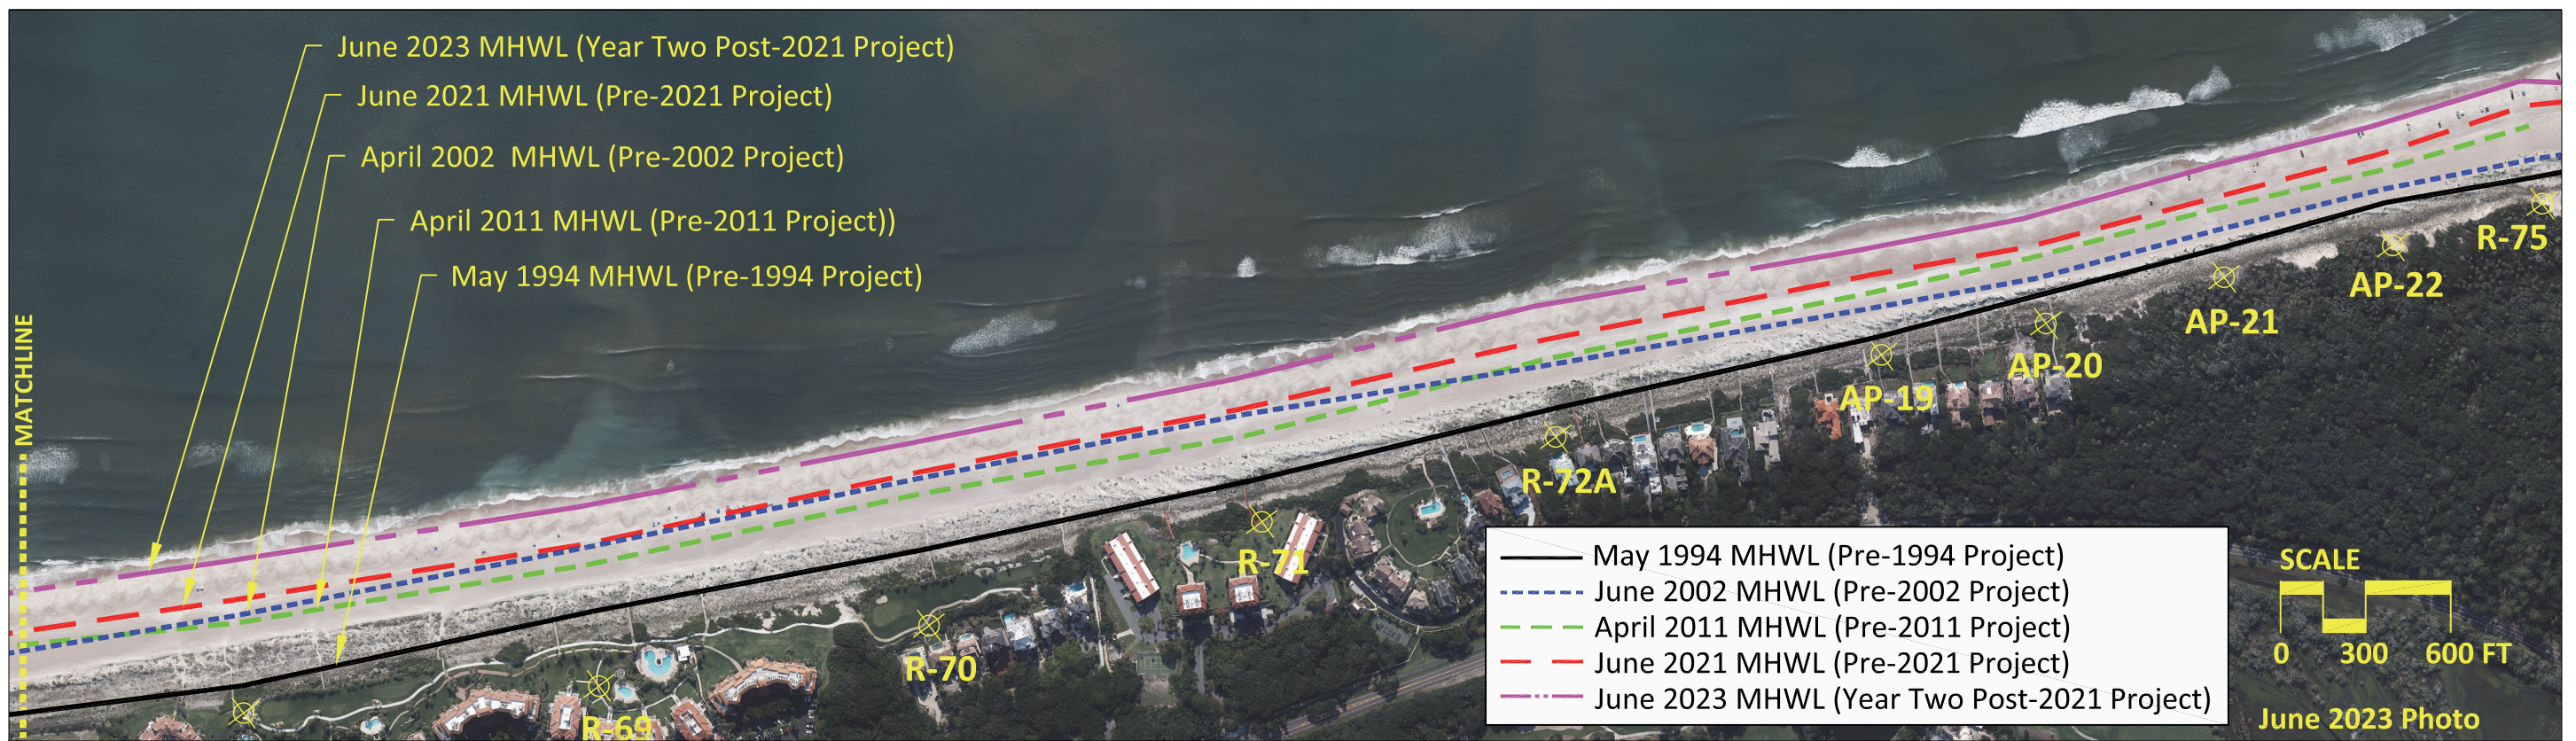
Figure 2.11: MHWL shorelines within the SAISS project limits (R-59 to R-75)

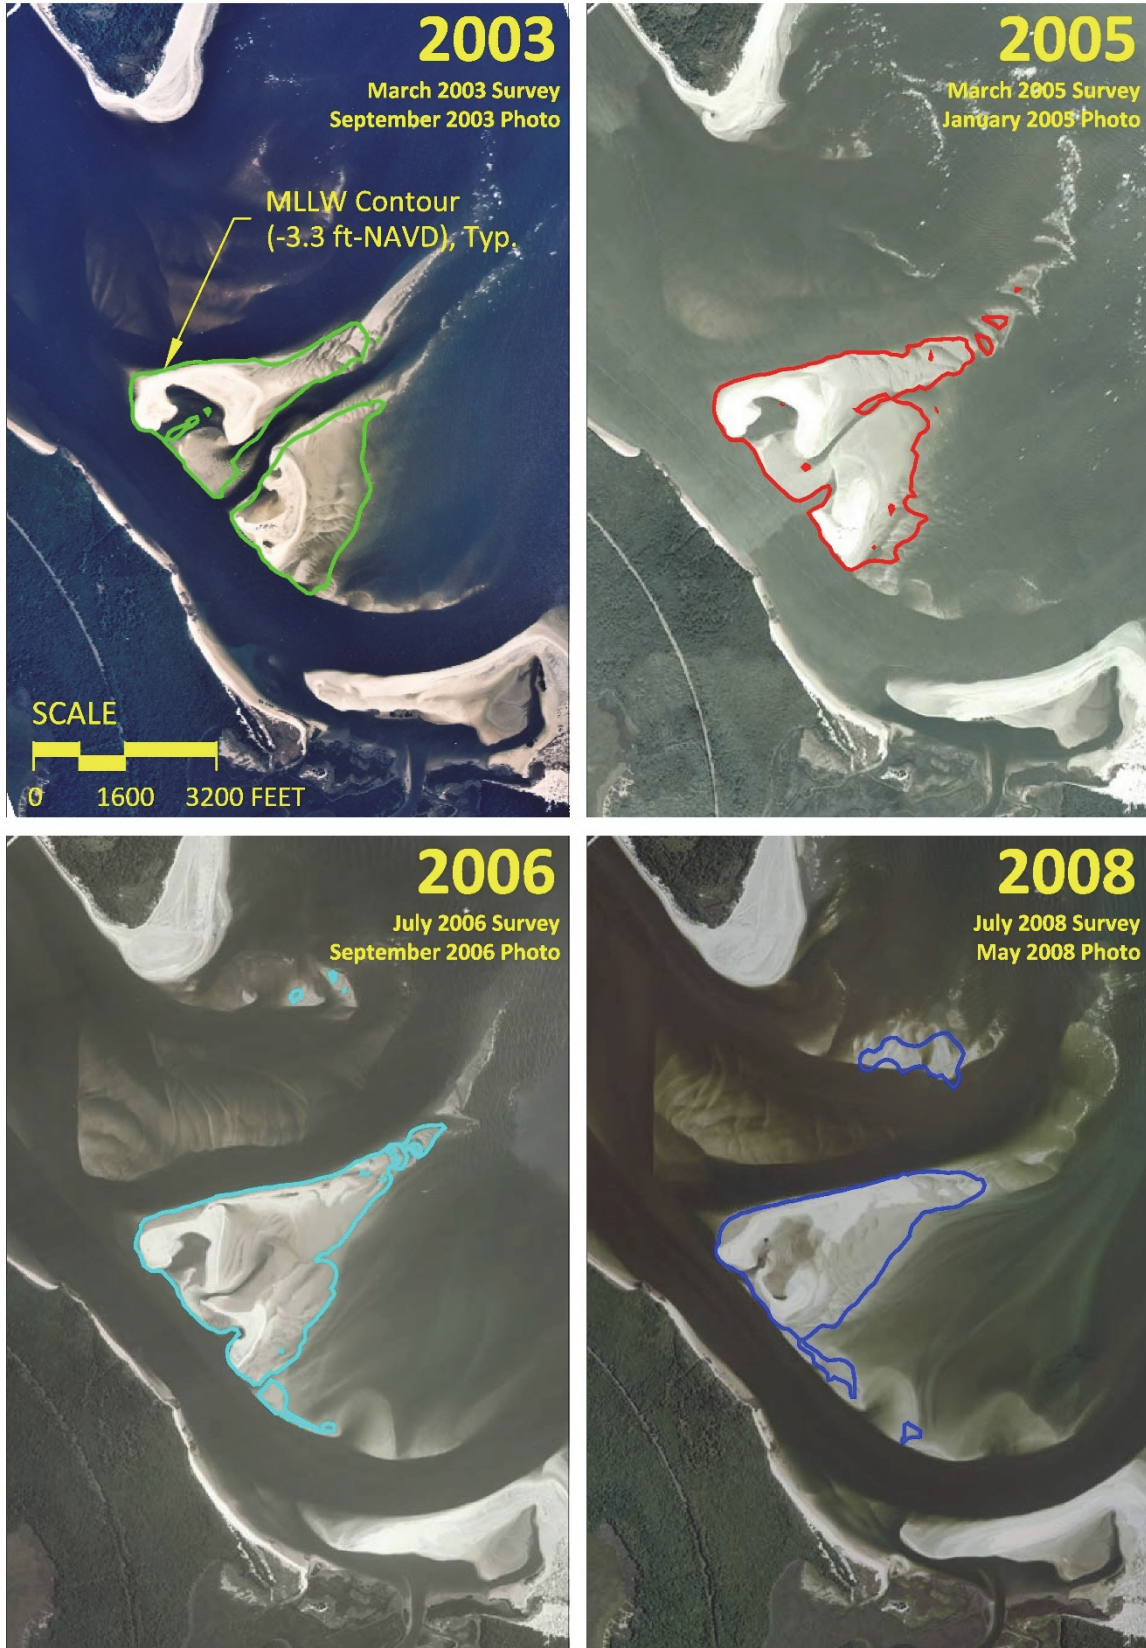
Figure 3.4a: Bird Island Shoal location (March 2003 to June 2020).

For purposes of tracking the changes in the Bird Island shoal complex, a spatial analysis was performed of the land mass above the mean lower low water line (MLLW), as defined by the -3.3 ft contour, for each survey of the emergent portion of Bird Island shoal (see **Figure 3.4ab**). The measured acreages above the MLLW contour for each survey date are presented in **Table 3.2**.

Over the approximate 244-month period of analysis, the size, location and shape of the shoal has changed significantly (see **Figure 3.4ab**). These changes in the shoal configurations, including changes to the Bird Island shoal complex, are expected to continue as the channels in the Sound continue to migrate southward. Recently a major northerly shift of the channels occurred. With the major shift of the northern channel to the north, shoal features can potentially re-form in the broader area between channels. This cyclical pattern has been observed in the past at Nassau Sound. **Figure 3.5** depicts a similar history of migration and changes in shoal size and location migration within the Sound, based upon aerial photography dating back to the 1940's.

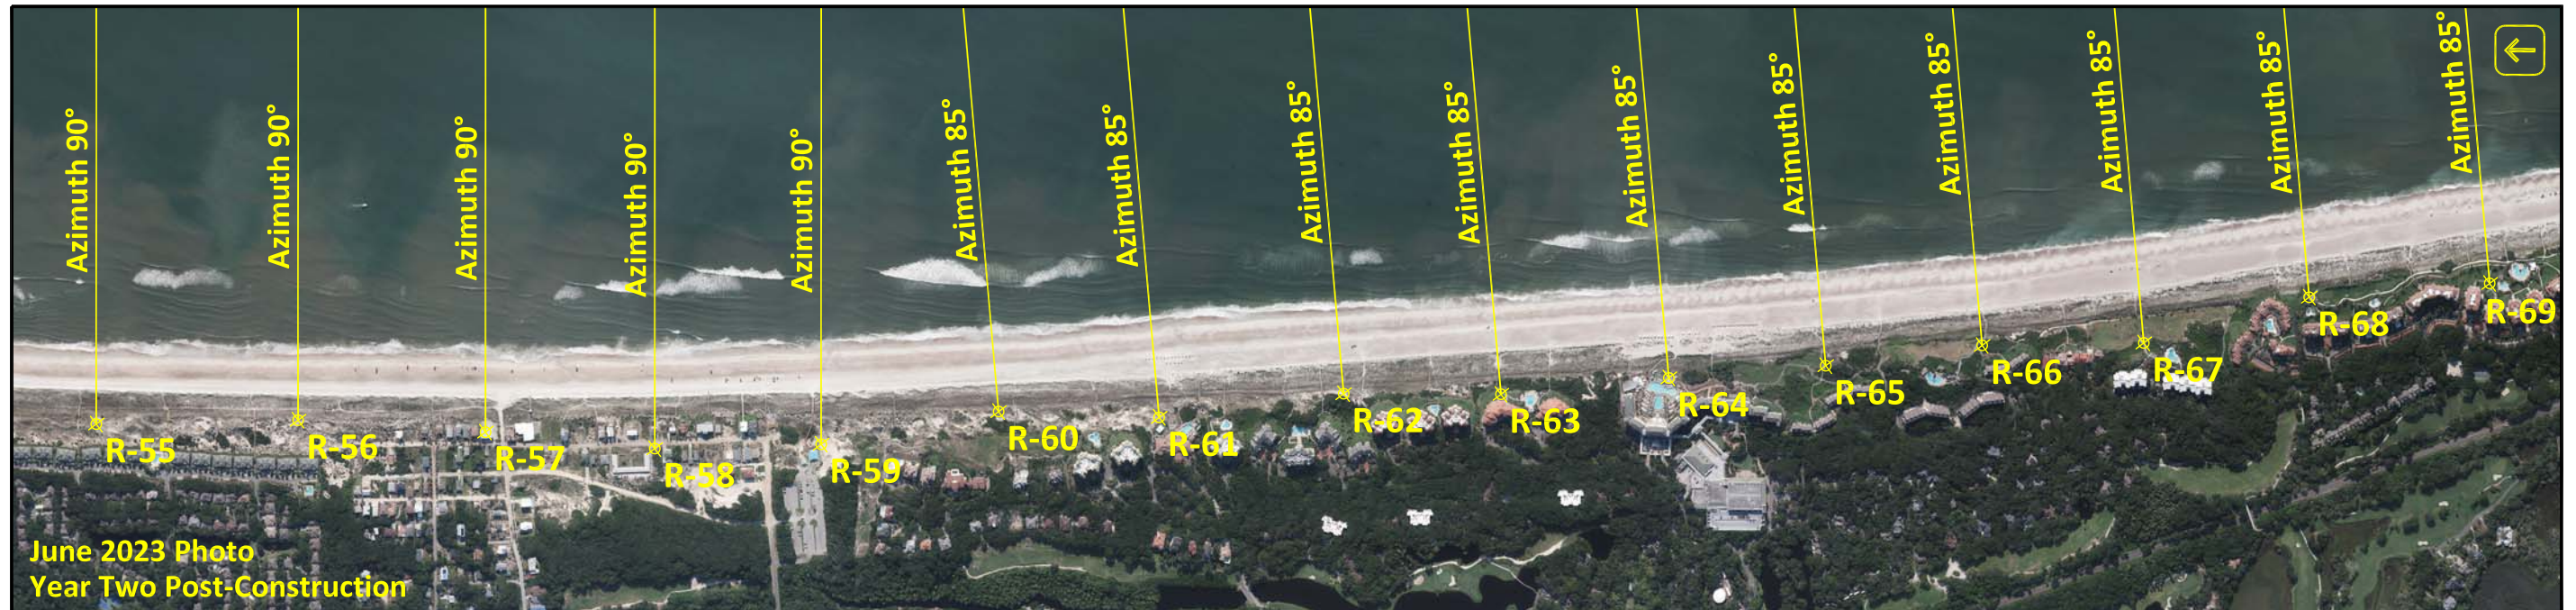
Figure B.1: Amelia Island beach profile monument locations.

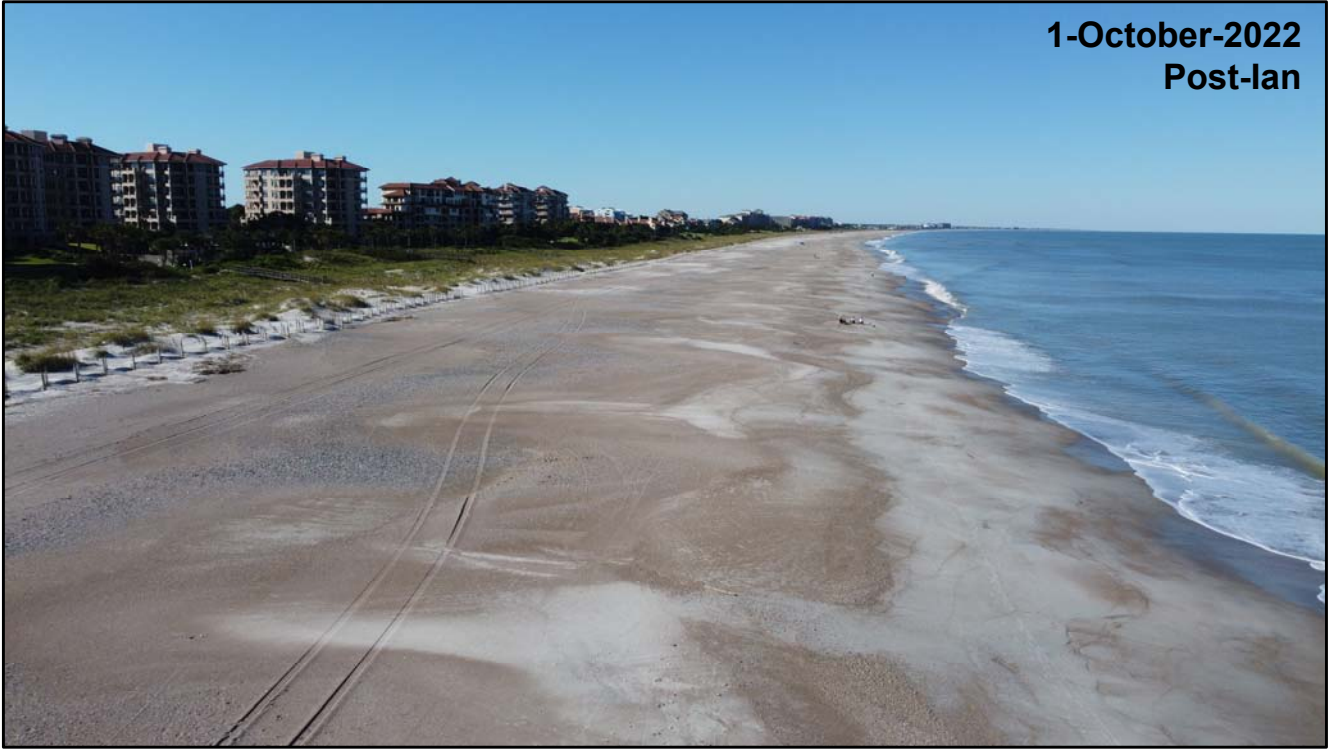
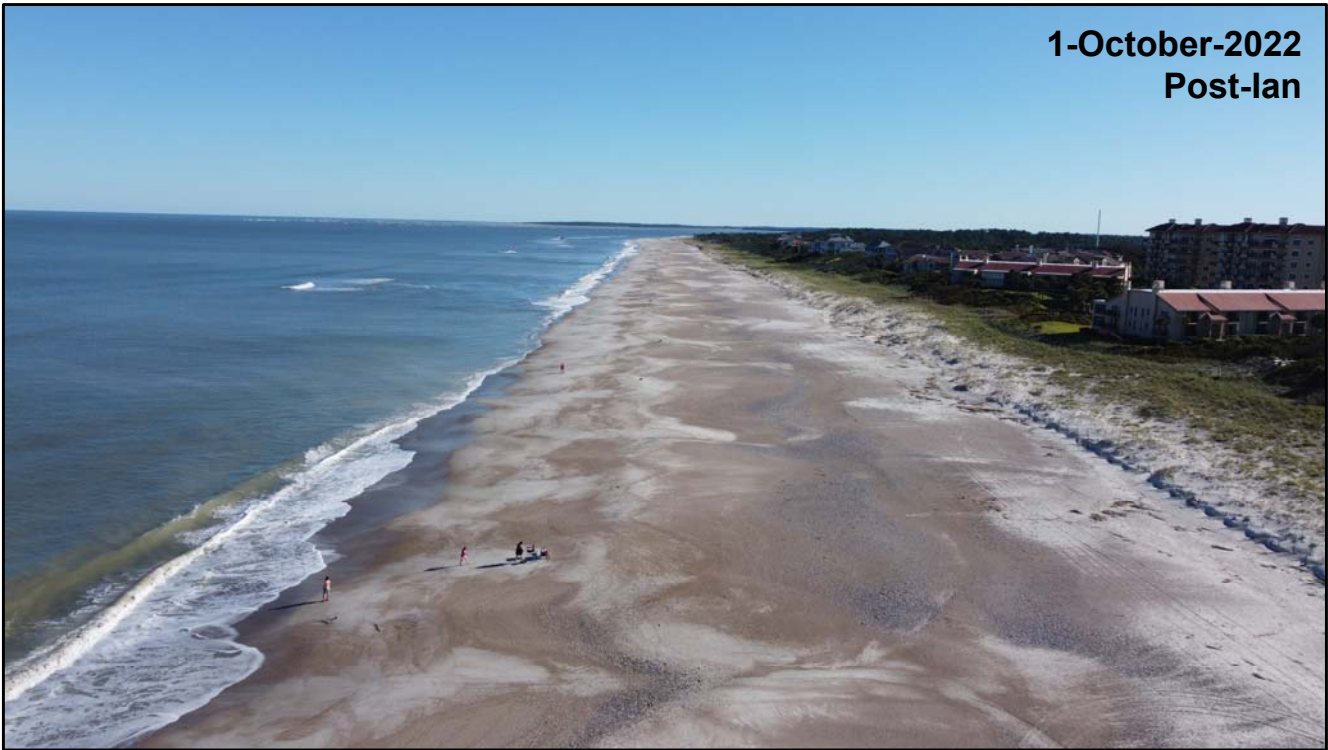
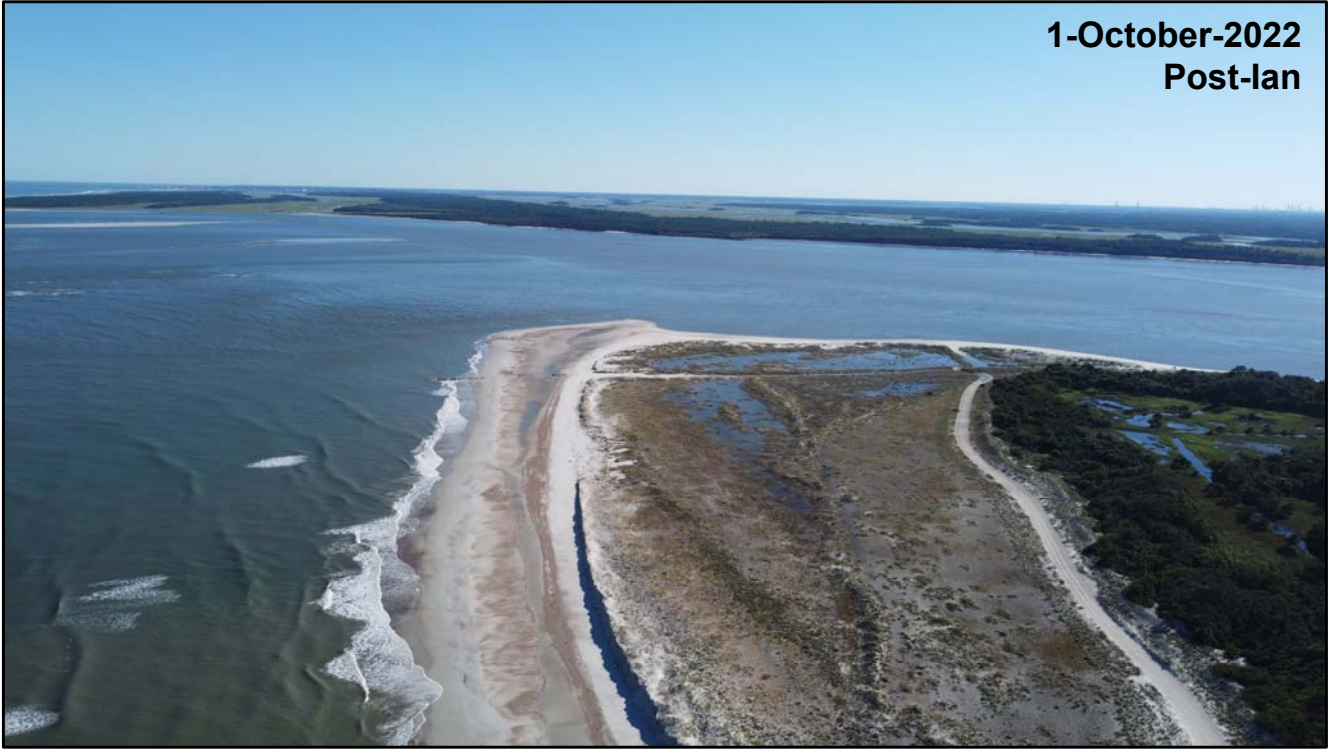
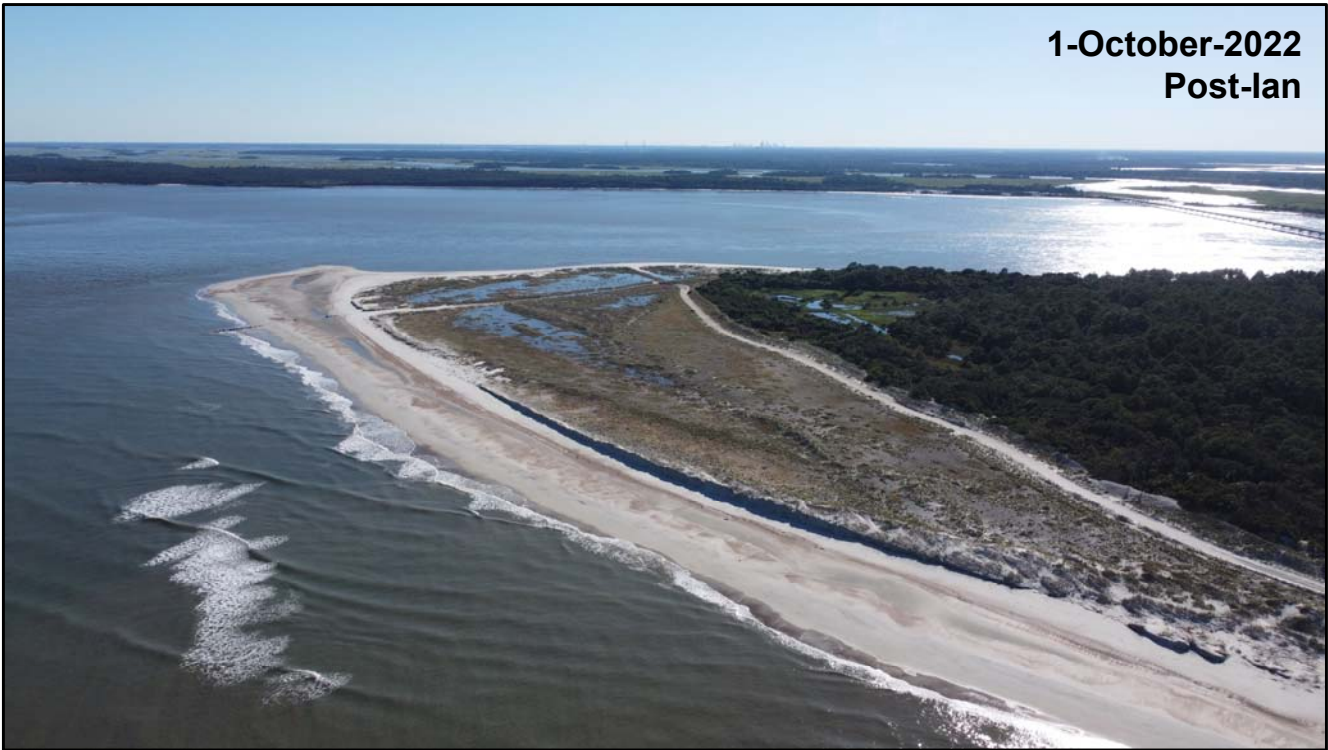
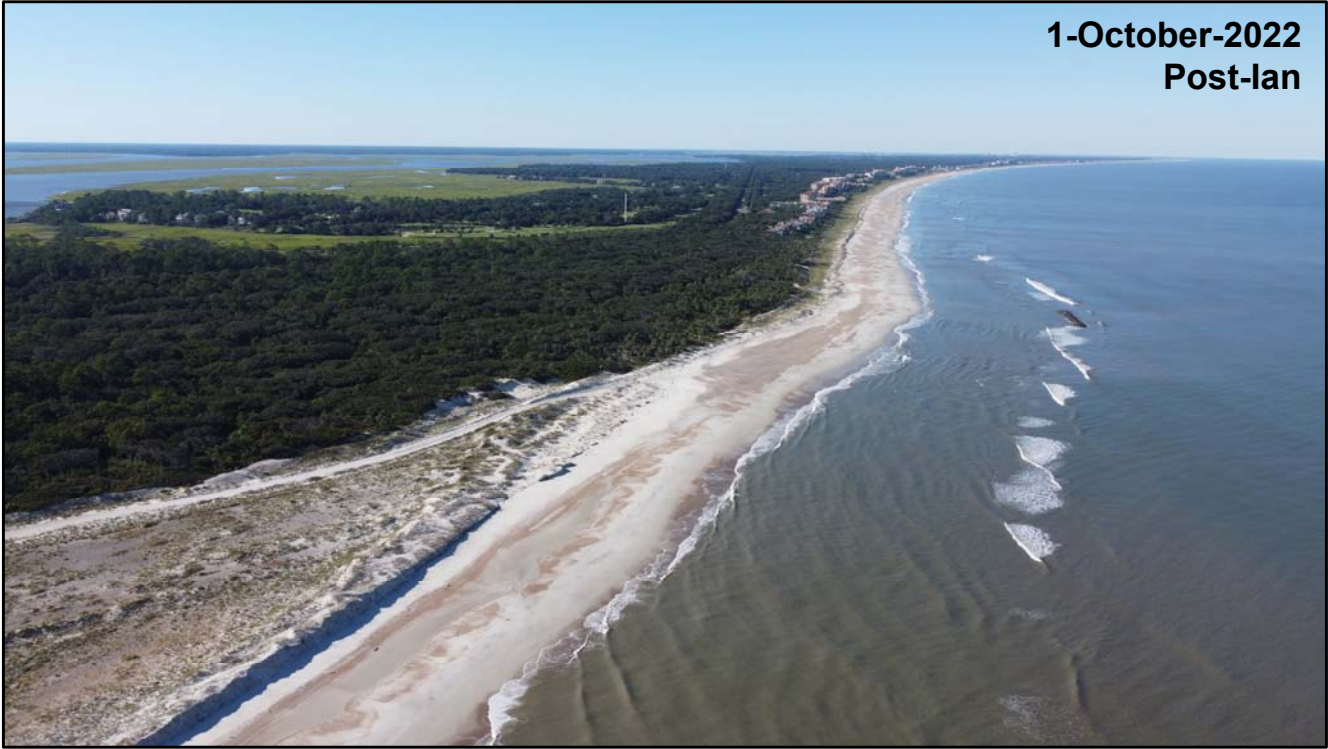
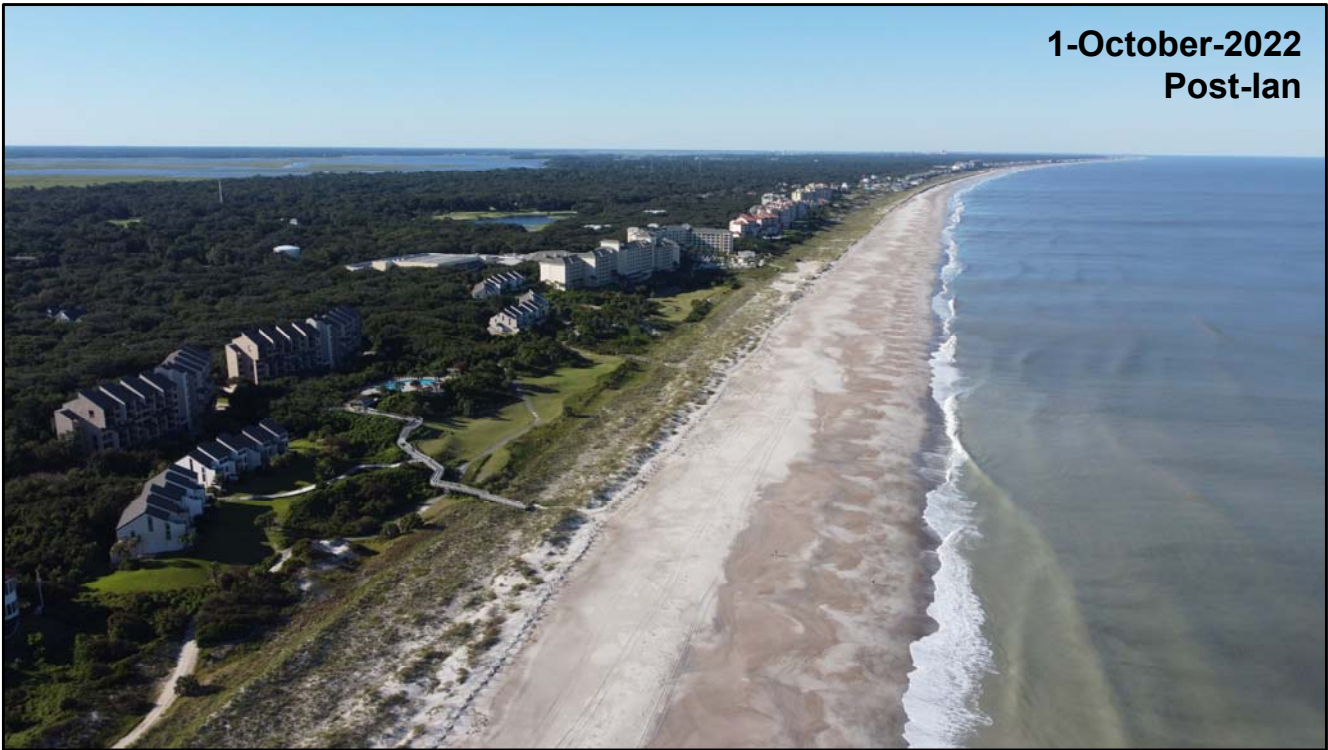
**October 1, 2022
Post Hurricane Ian**

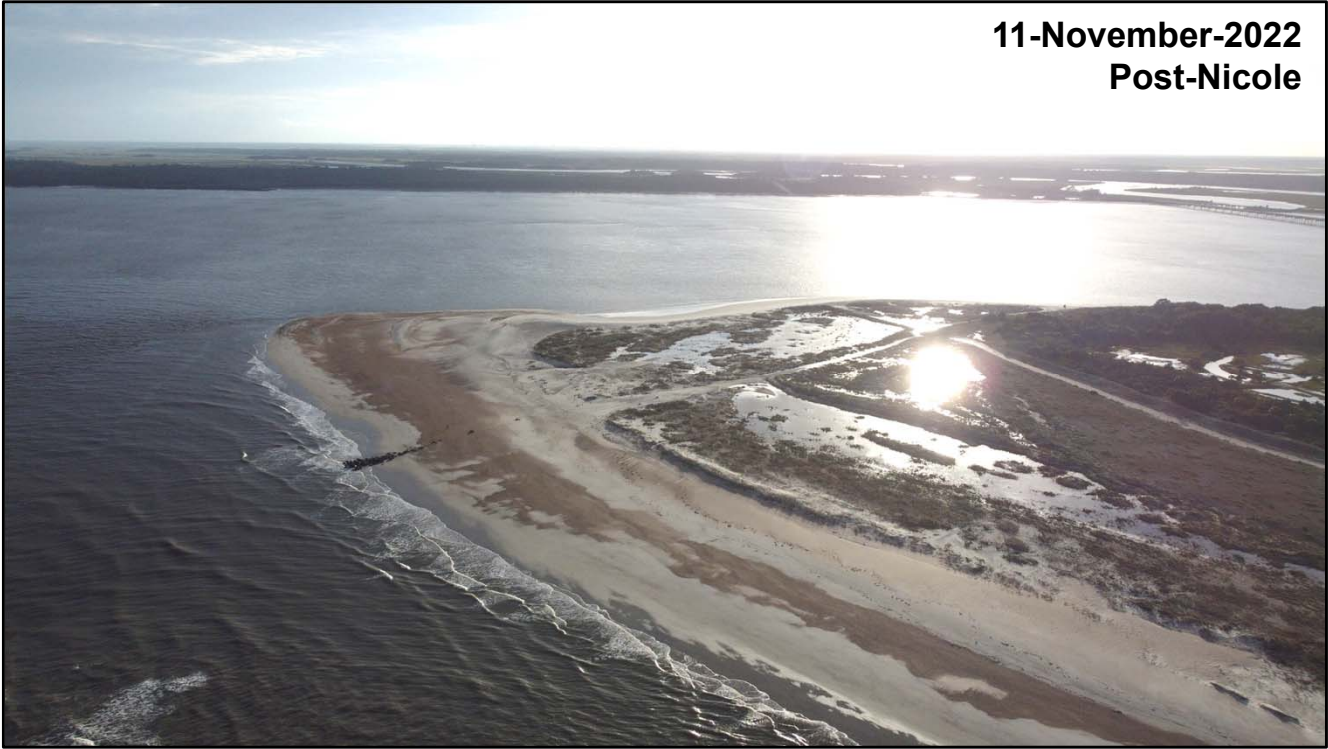
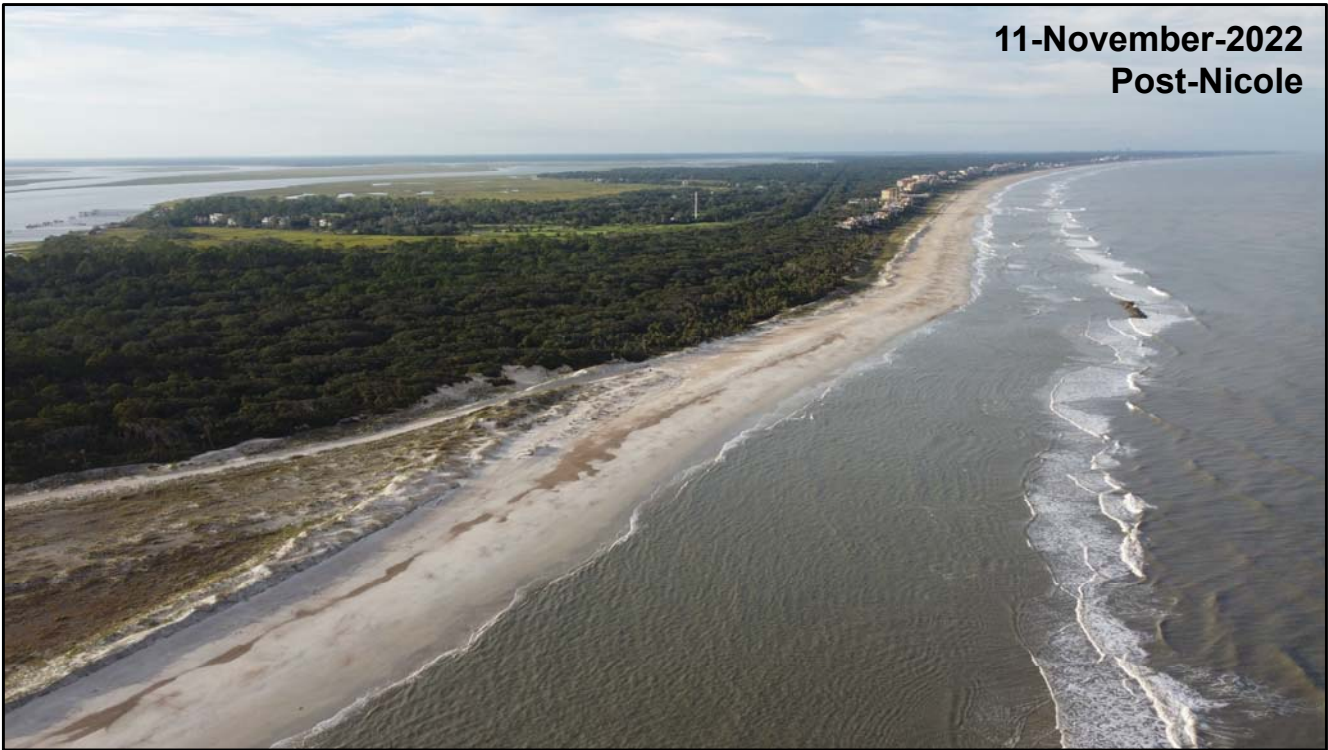
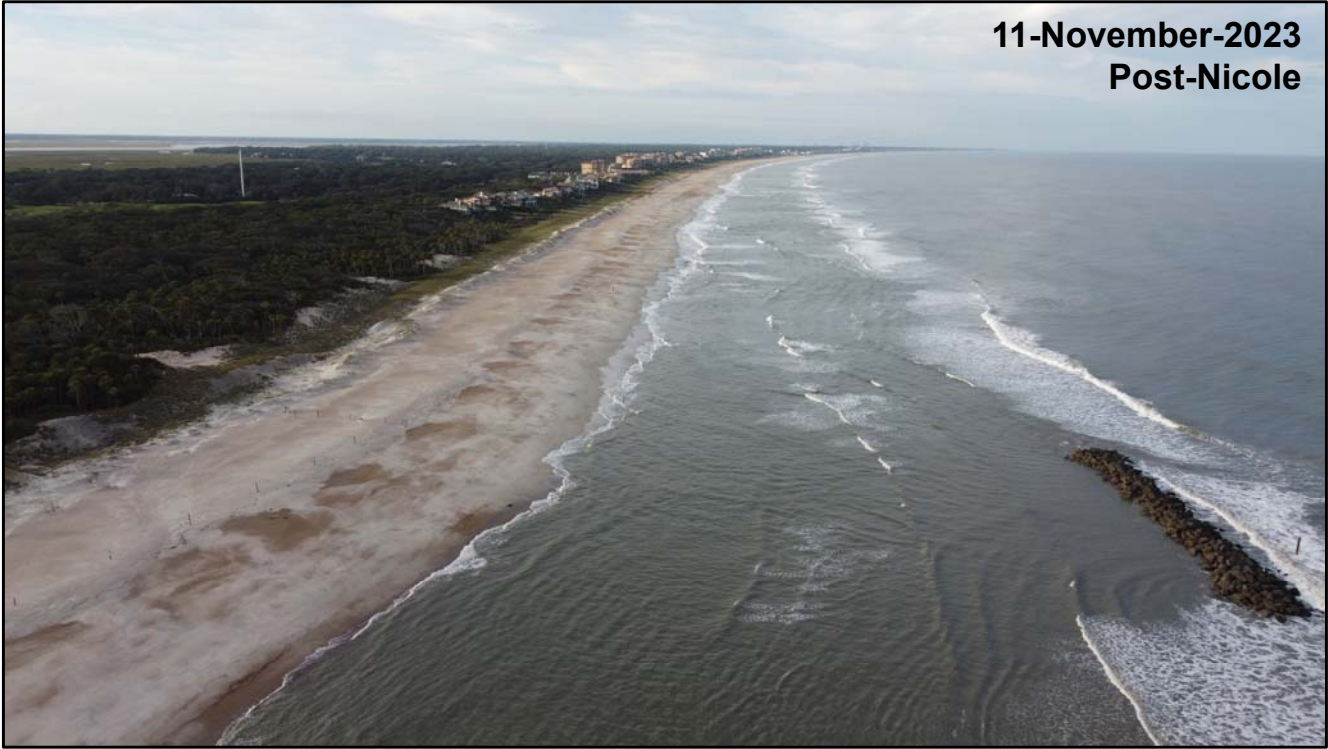
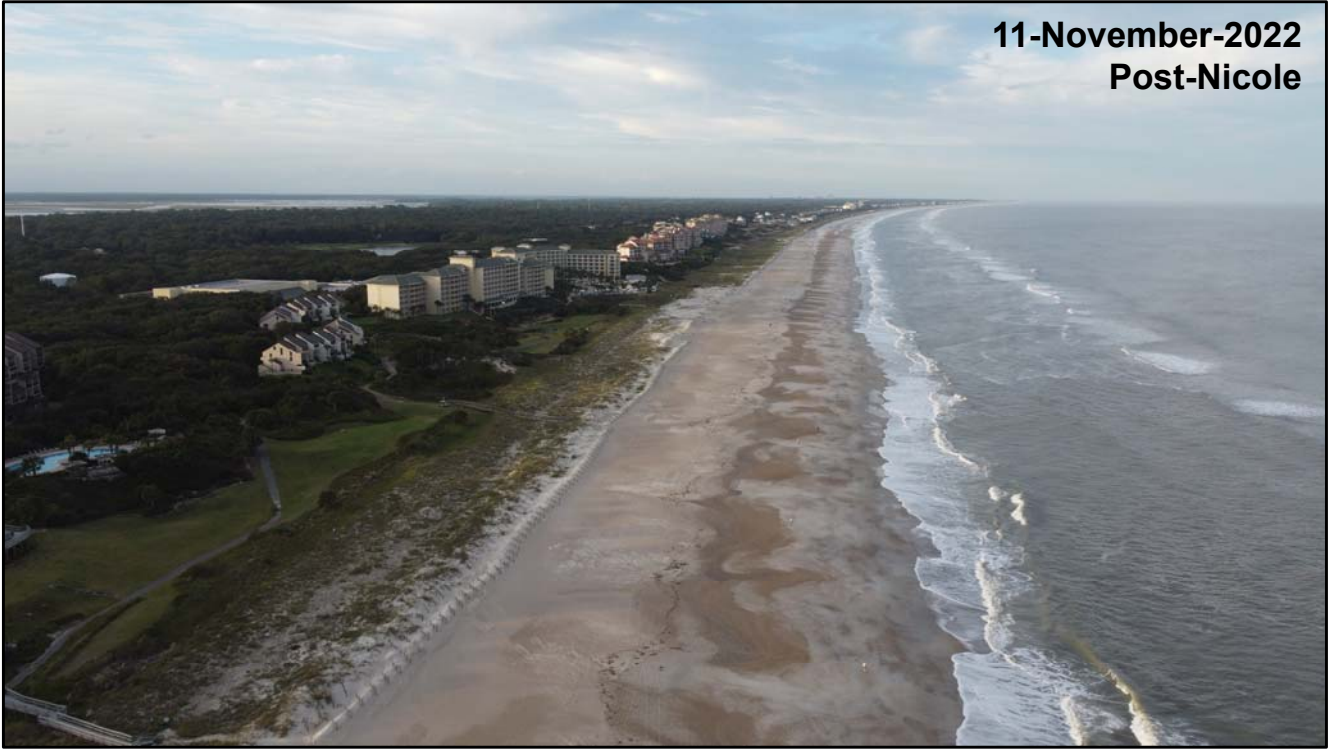
**November 11, 2022
Post Hurricane Nicole**

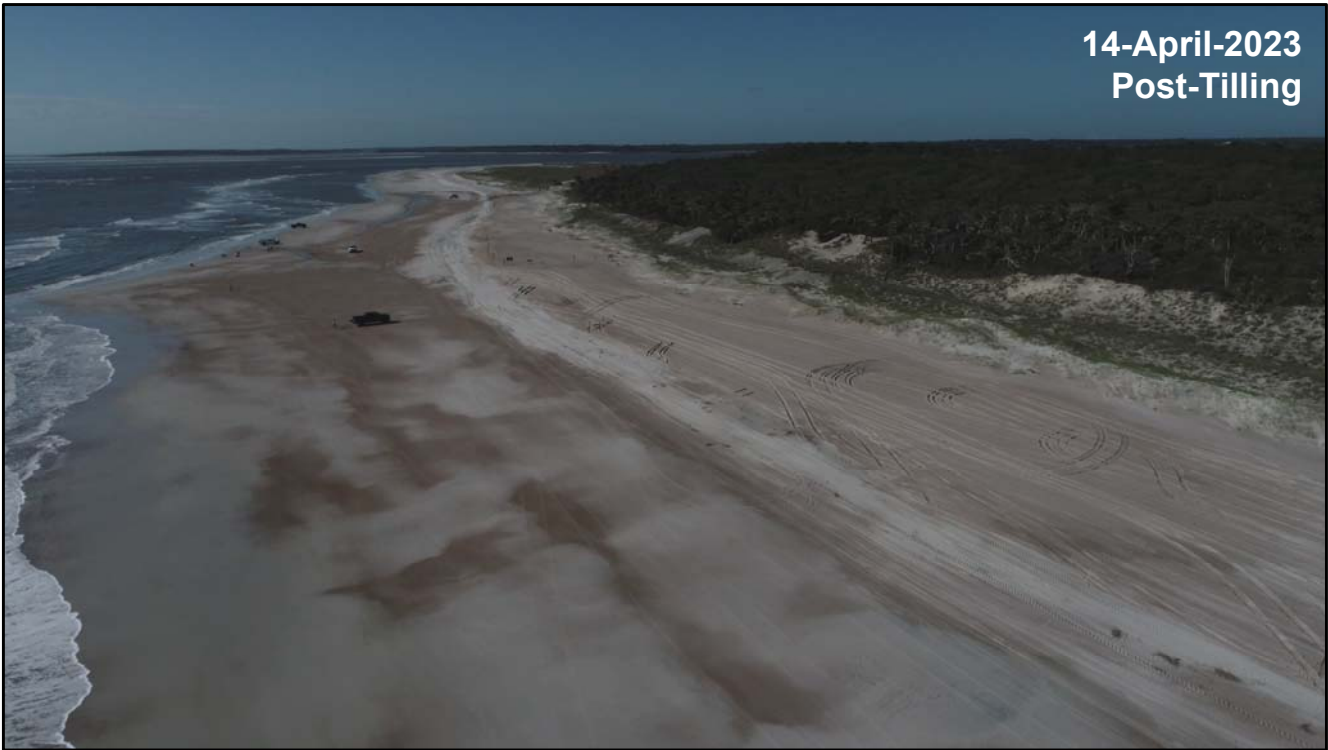
14-April-2023
Post-Tilling

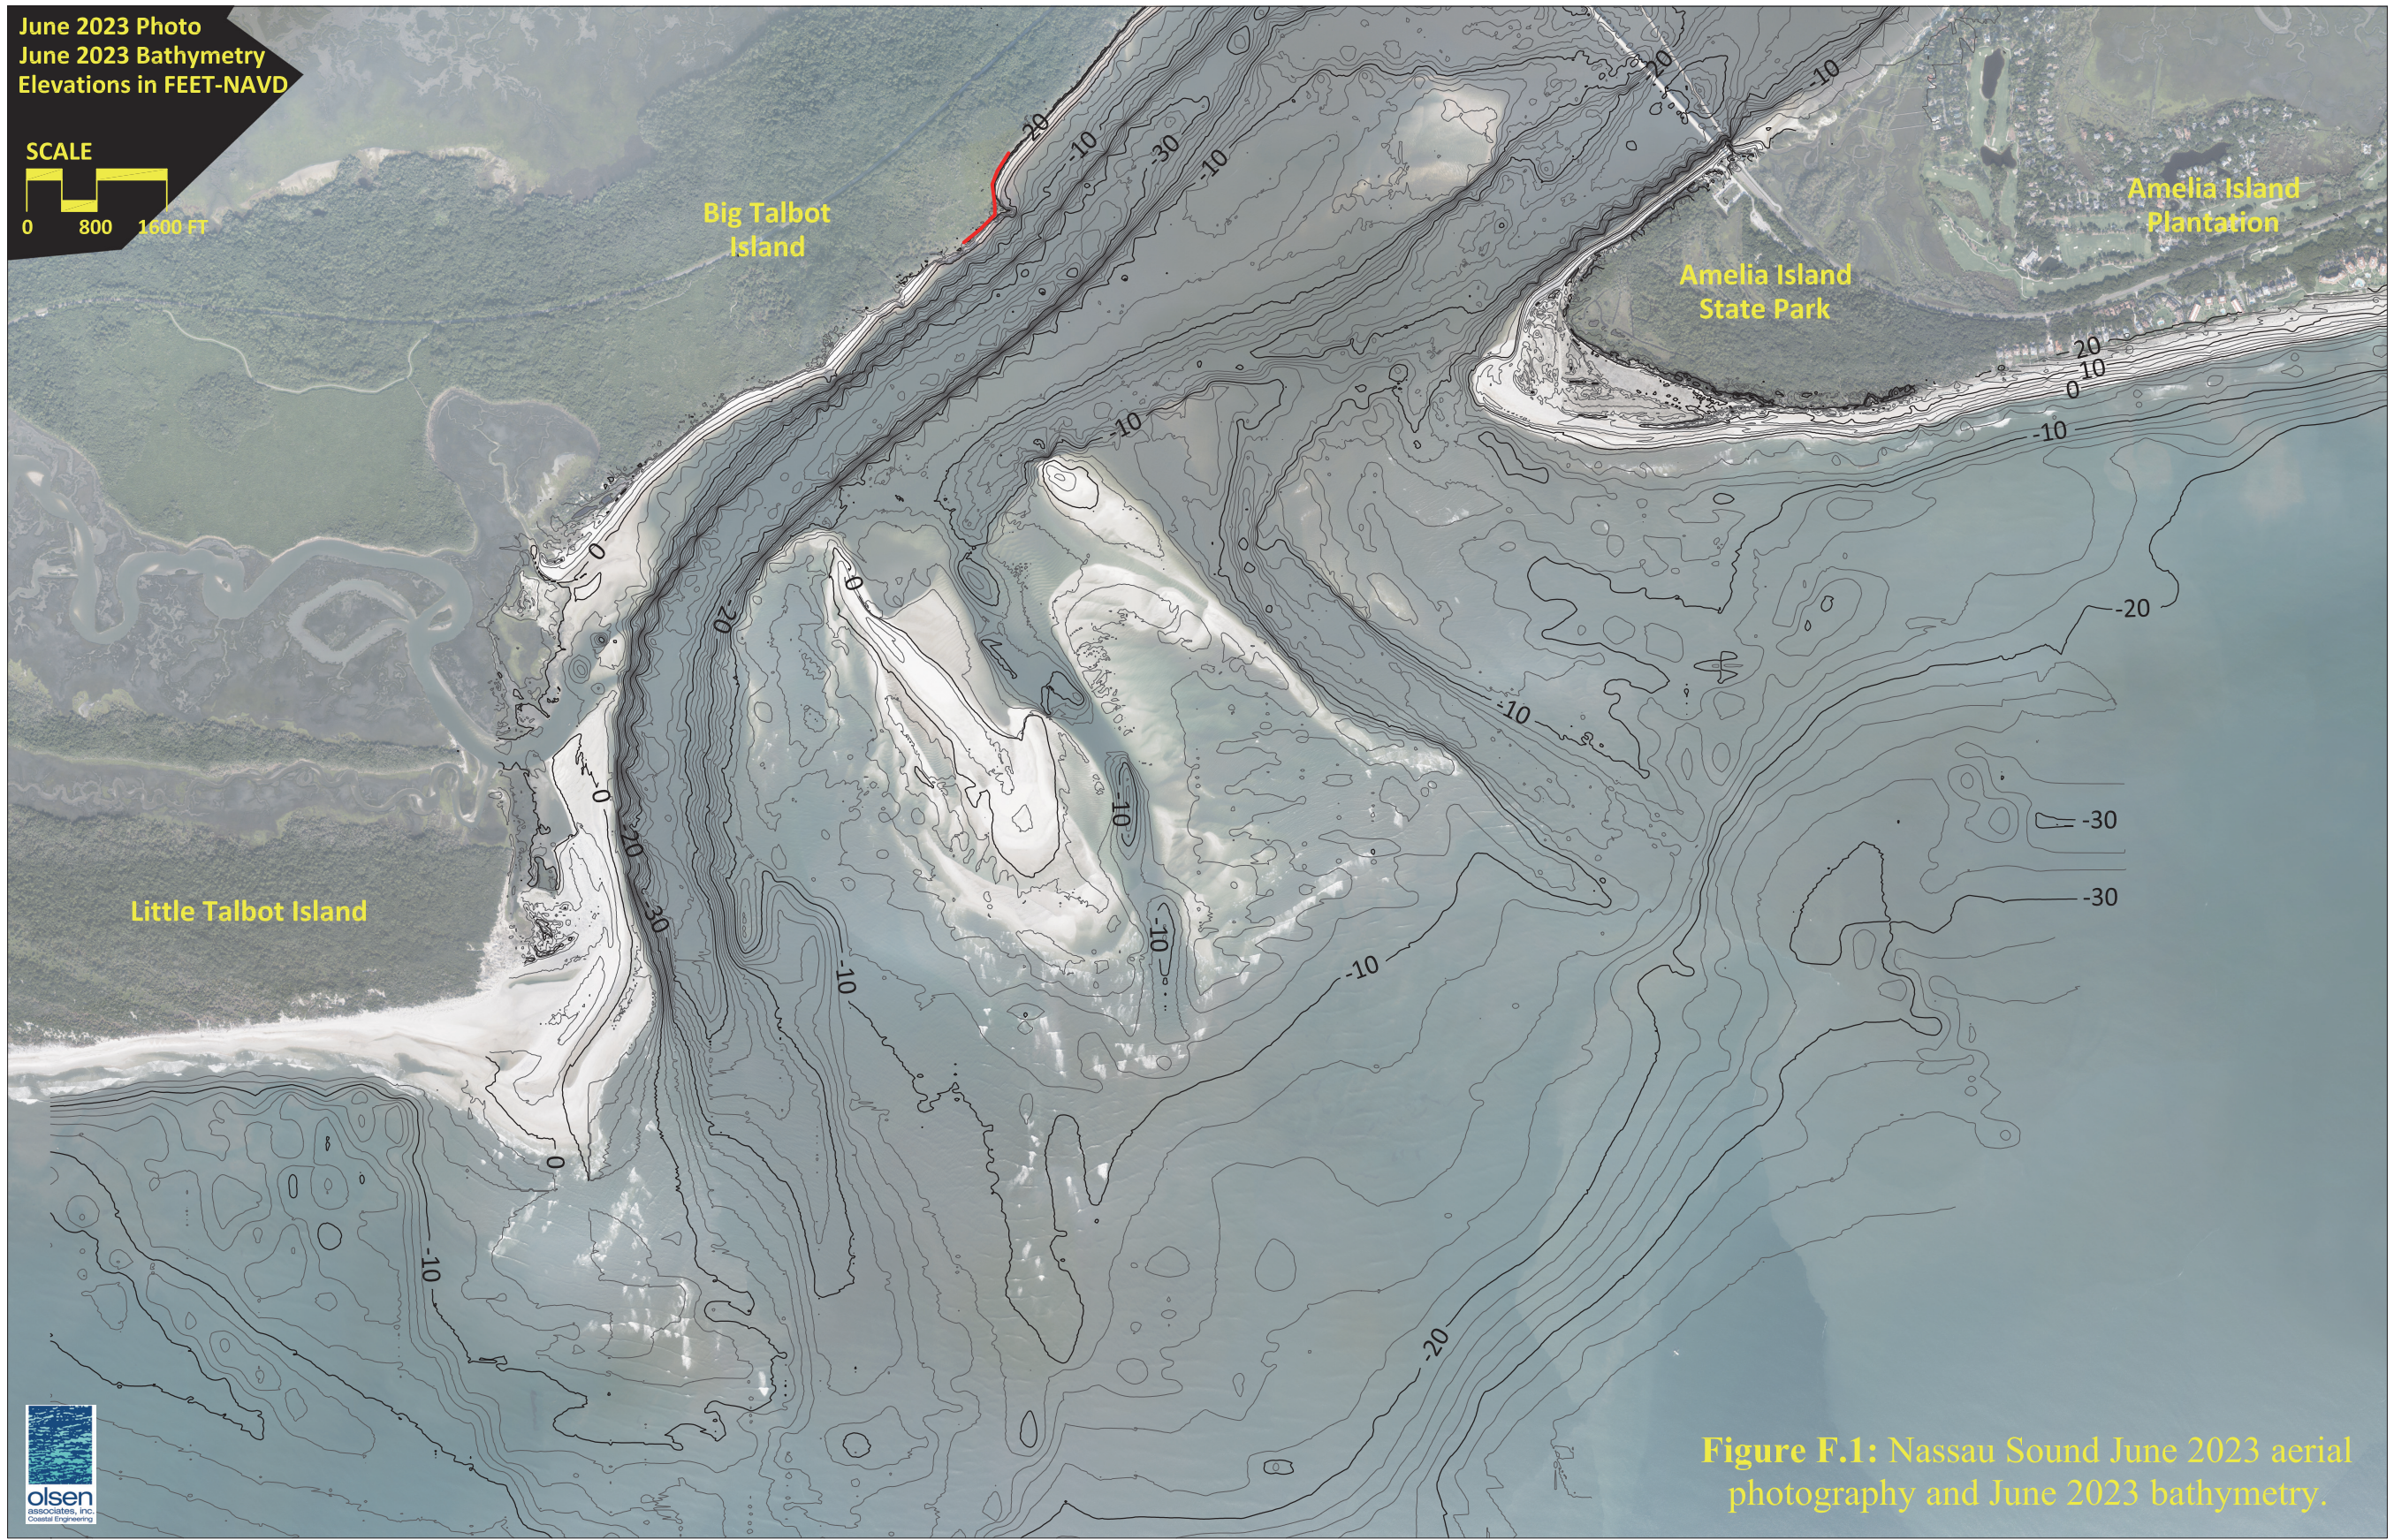
Figure F.1: Nassau Sound June 2023 aerial photography and June 2023 bathymetry.
